STREMAH 2021

ARCHIVE RESEARCH AS A DIAGNOSTIC AND COGNITIVE INVESTIGATIVE METHOD OF MEMORY OF THE MULTISTRATIFIED URBAN BUILT HERITAGE: A CASE OF URBAN ARCHEOLOGY

LUCREZIA LONGHITANO, SANTI M. CASCONI,
STEFANO CASCONI & GIUSEPPE A. LONGHITANO
University of Catania, Italy

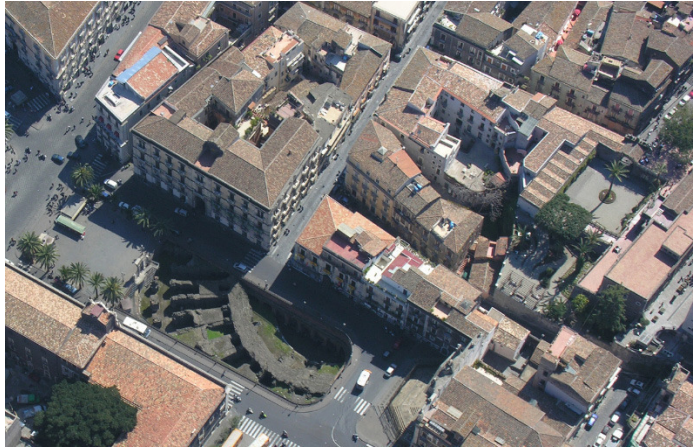
Figure 1: Piazza Stesicoro overlooking the ruins of the amphitheater, north-west view. (Source: *Poloregionale.net*.)

Focusing on the case of the amphitheater, that is subject of this research, it is incorporated in the urban stratification following the earthquake of 1693, in the area of Piazza Stesicoro (Fig. 1). Among the original 56 sectors, only 22 remain, divided between an uncovered area, visible from the square and set up in 1906, and a hypogea area, underlying modern structures.
