Photogrammetry-Drone-Based Tool for Structural Vulnerability Assessment in Historic Urban Centers

C. Nava et al. (Eds.): *Climatic and Structural Safety in Multi-Hazard Regime of Cultural and Natural Heritage*, GREEN, pp. 196–205, 2026.

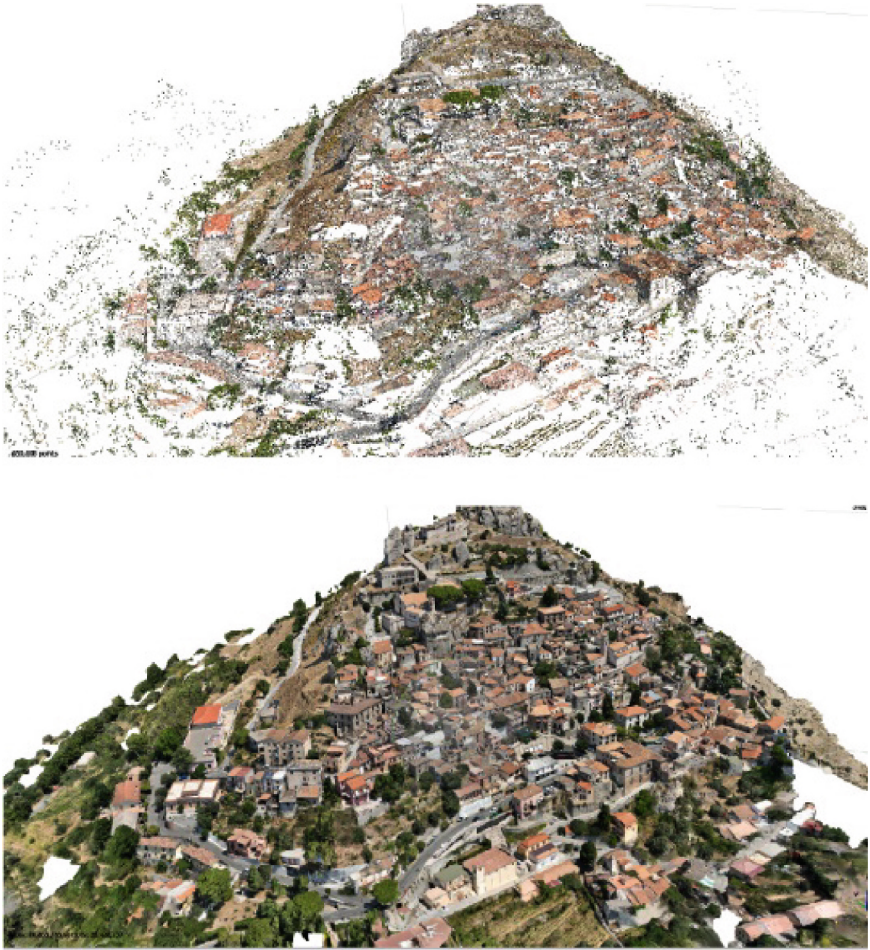
Fig. 2. Comparison between dense point cloud generated by SfM (top image) and 3D mesh model with high-resolution texture mapping (bottom image) of Bova's historic center.

Image data acquired from the UAV survey were processed using the Structure from-Motion (SfM) photogrammetry technique. The workflow included image alignment, generation of sparse and dense point clouds, mesh reconstruction and high-resolution texture mapping. Figure 2 shows a comparison of the dense point cloud and the final textured 3D model used.

All operations were conducted in Agisoft Metashape standard version 2.2 (2025), a widely adopted platform for architectural and heritage documentation. The output dataset contains a detailed 3D model of the historic area with textures, true-scale orthophotos for flat measurements and a georeferenced points cloud for spatial referencing and additional measurements. These outputs give a complete 3D visual view of Bova's historic center which provides the geometric and visual foundation for all future steps, allowing structural and typological information.
