Article

A Nature-Based Approach Using Felled Burnt Logs to Enhance Forest Recovery Post-Fire and Reduce Erosion Phenomena in the Mediterranean Area

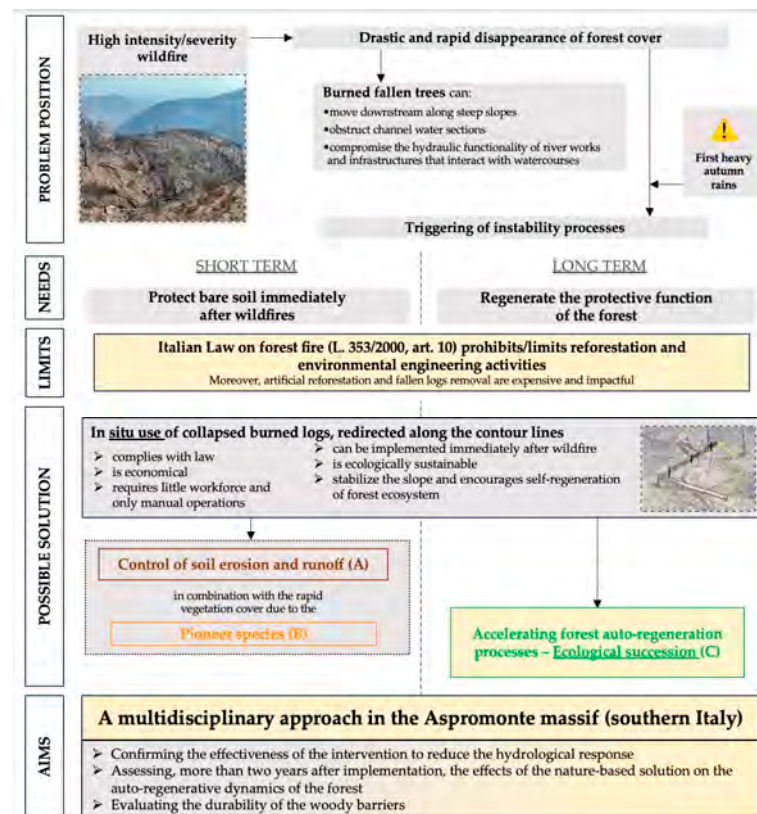
Figure 1. Conceptual-logical scheme used to articulate the work, illustrating the critical issues and opportunities associated with the use of in situ felled burnt logs for ecosystem regeneration.

The logical path in the survey approach is illustrated in Figure 1. According to the aims of the work and in order to verify the effectiveness of the measure, the various actions have both short- and long-term implications, as separated by the dotted line. The activities for which preliminary results have already been obtained (one year after the event, 2022) are shown in the grey boxes; in the present work, they have been further monitored covering an additional year of observation in continuity with the methodologies already available. The new investigations planned to give an integrated and multidisciplinary approach to the investigation are, instead, highlighted by the yellow boxes.

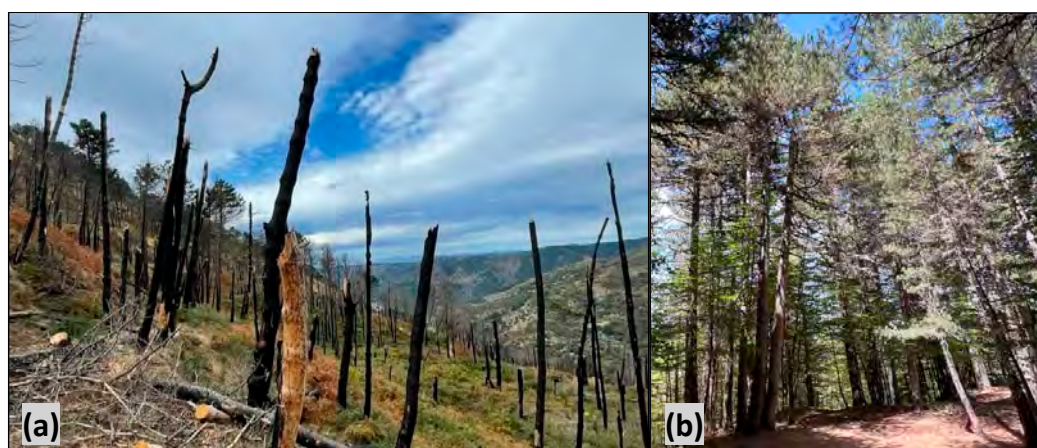
Scheme 1. Representative photos of (a) the Aspromonte areas affected by the wildfires of summer 2021 and (b) the high density of *Pinus radiata* forest in Aspromonte.

In particular, a total surface of 5589.27 ha was damaged by fire (Figure 2): 1319.81 ha within the so-called “A zone”, representing natural reserve areas; 1658.45 ha and 1961.73 ha for the lower protection zones B and C, respectively. Among the others, the fire mostly damaged natural pine forests of endemic black pines (886.46 ha; *Pinus nigra* J.F. Arnold subsp. *laricio* Palib. ex Maire). The mountain area, moreover, was subjected to several reforestation operations over the last 70 years; therefore, it is also characterised by a high density of artificial forest of *Pinus nigra* to which is added the *Pinus radiata* D. Don (800–1000 per ha with a height ranging from 14 to 20 m and crown diameters from 4 to 7.5 m), non-native species that have, however, become dominant (photo 1b) [58].

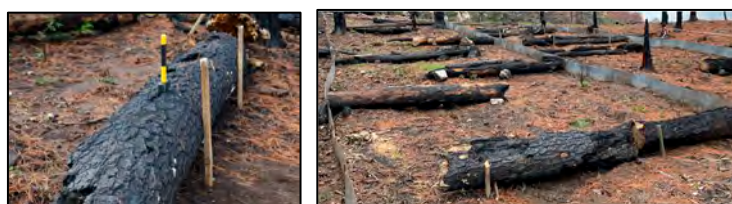
Sub-plots B	Length of downed logs: 1.5 to 4 m
Sub-plots BR	Length of downed logs: $\cong 4$ m; average diameter = 33 cm (from 21 to 49 cm) Downed logs redirected following the contour lines of individual sub-plots and reallocated at an average downslope distance of 4 m, resulting in partial fragmentation of the slope path; fixed with wooden stakes. The ratio between the sub-plot area (110 m^2) and the total length of the contour logs was within the range of 3.9–4.6 m.

Only manual work (for in situ manual rotation of downed logs, two operators for few days ha^{-1}) and light equipment (hammer) were required.

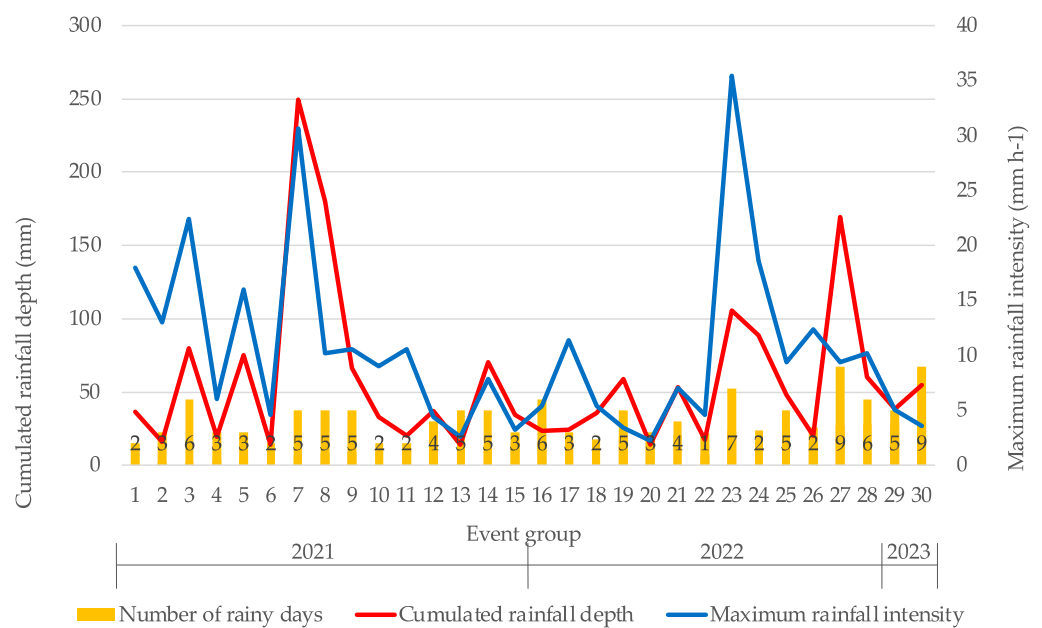
Figure 4. Main of rainfall events recorded by the meteorological station located in Roccaforte del Greco, southern Calabria, Italy.

Rainfall data were recorded at the meteorological station in Roccaforte del Greco (about 3 km away from the experimental site) and summed (except in one case) to overcome the logistical limitation (distance and impervious mountain environment) that did not make it possible to follow the hydrological response after each single rainfall event group. The maximum rainfall intensity (mm h^{-1}) within each event group was calculated. A total of 30 event groups were cumulated (six more than the previous observation, extending the time window from October 2022 to January 2023, Figure 4).

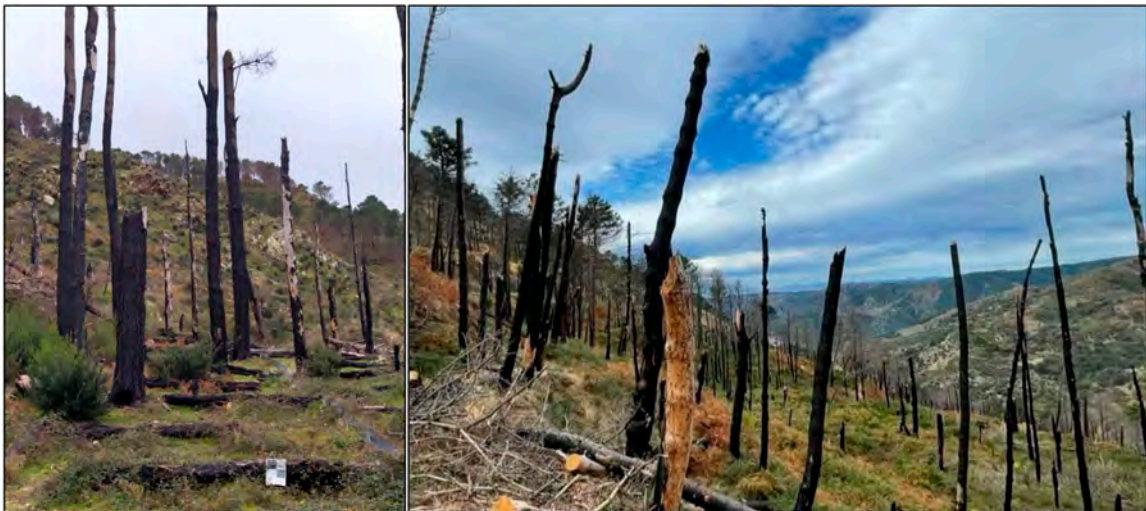
Scheme 3. Auto-succession process of *Pinus radiata* (2 years old) within the BR plot block (redirected felled burnt logs) that emerges once the pioneer vegetation (that suppressed it) is now degraded.

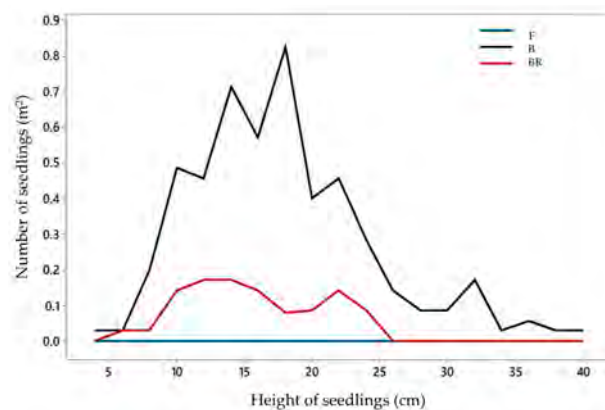
Figure 9. Seedling distribution according to height class of *Pinus radiata* one year after the wildfire.

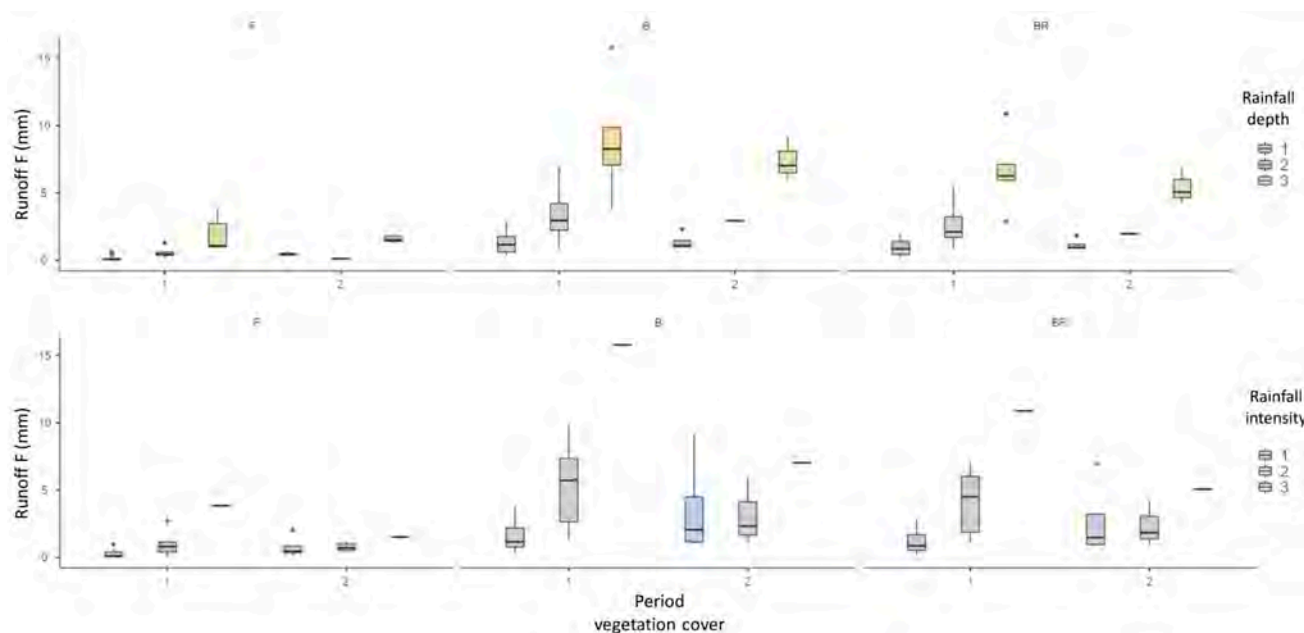
Figure 12. Box plot diagram of the runoff values in the study plots. Vegetation cover periods were established from September 2021 to June 2022 (phase 1), and the second was established from June 2022 to January 2023 (phase 2). Rainfall depth: 1st category, values between 0 and 35 mm; 2nd category, values between 35 and 70 mm; 3rd category, values greater than 70 mm. Rainfall intensity: 1st category, values between 0 and 10 mm h⁻¹; 2nd category, values between 10 and 30 mm h⁻¹; 3rd category, values greater than 30 mm h⁻¹.

Regarding surface runoff, there were no significant changes in sediment yield ($p < 0.996$) for all the plots in both periods of the vegetation cover analysed (Table A4). The post hoc comparison (Table A5) showed no significant changes in the within-plot analysis (p -values of 0.874 for F plot block, 0.896 for B and 0.845 for BR), where the pioneer vegetation growth did not significantly alter surface runoff; just higher values of rainfall intensity (value 3) induced within-plot changes (Figure 12). An inter-plot analysis of surface runoff, in which rainfall and rainfall intensity both played a significant role as covariates ($p < 0.001$) in the ANCOVA model, showed significant changes (Table A4). The surface runoff recorded in plots B and BR compared to plots F remained different in the two vegetation cover periods analysed (Table A5), particularly at the highest values of rainfall and intensity (Figure 12).

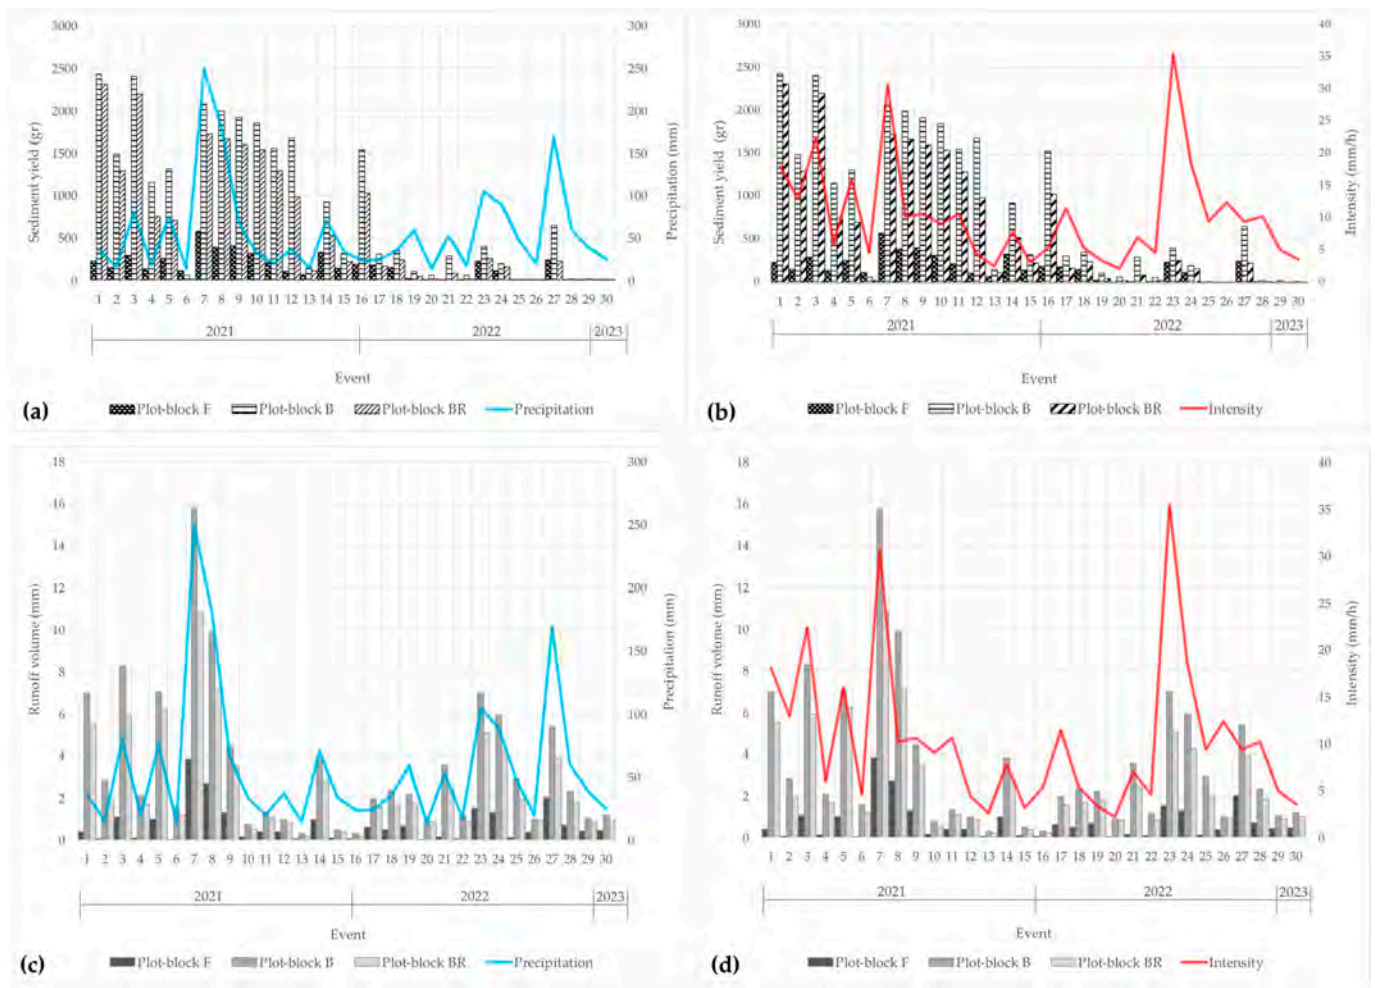
Figure A1. Evolution of sub-plot mean values ($n = 3$) of runoff volumes (a,b) and sediment yields (c,d) related to rainfall depth and maximum intensity.

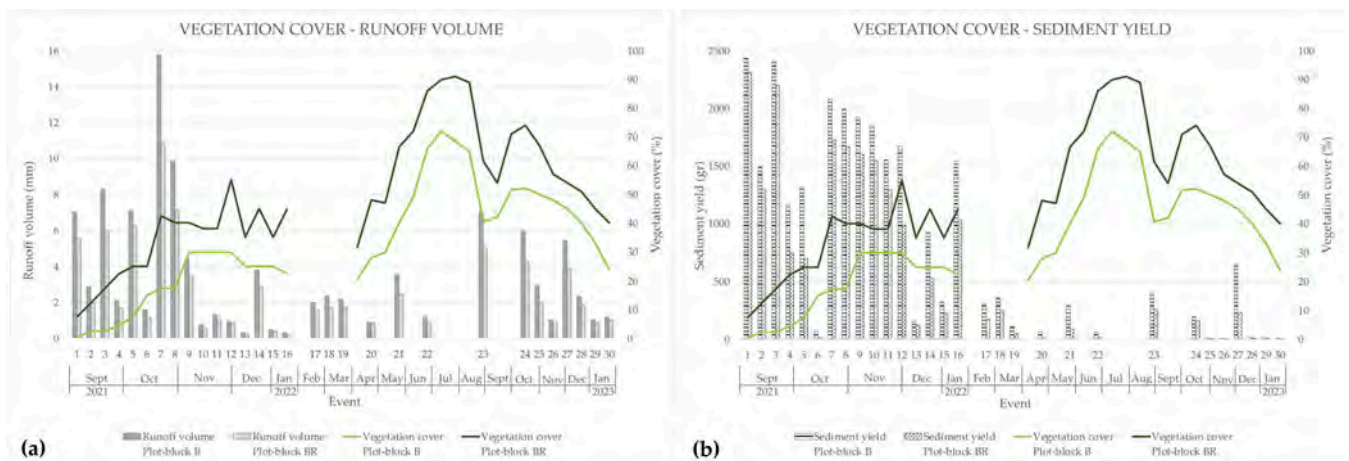
Figure A2. Evolution of vegetation cover in relation to runoff volume (a) and sediment yield (b).

Monitoring the degree of ground cover by pioneer species showed consistently higher values (34% on average; $n = 60$) in the BR plots [102]. The combined effect of redirected logs and vegetation becomes more evident from the 13th event, where, even with the most intense rainfall events, a drastic decrease in runoff volume and sediment production is observed (see, for example, events 17, 19, 23, 24 and 27, Figure A2).
