Title: Exploring the influence of vegetation cover, sediment storage capacity and channel dimensions on stone check dam conditions and effectiveness in a large regulated river in México

Article Type: Research Paper

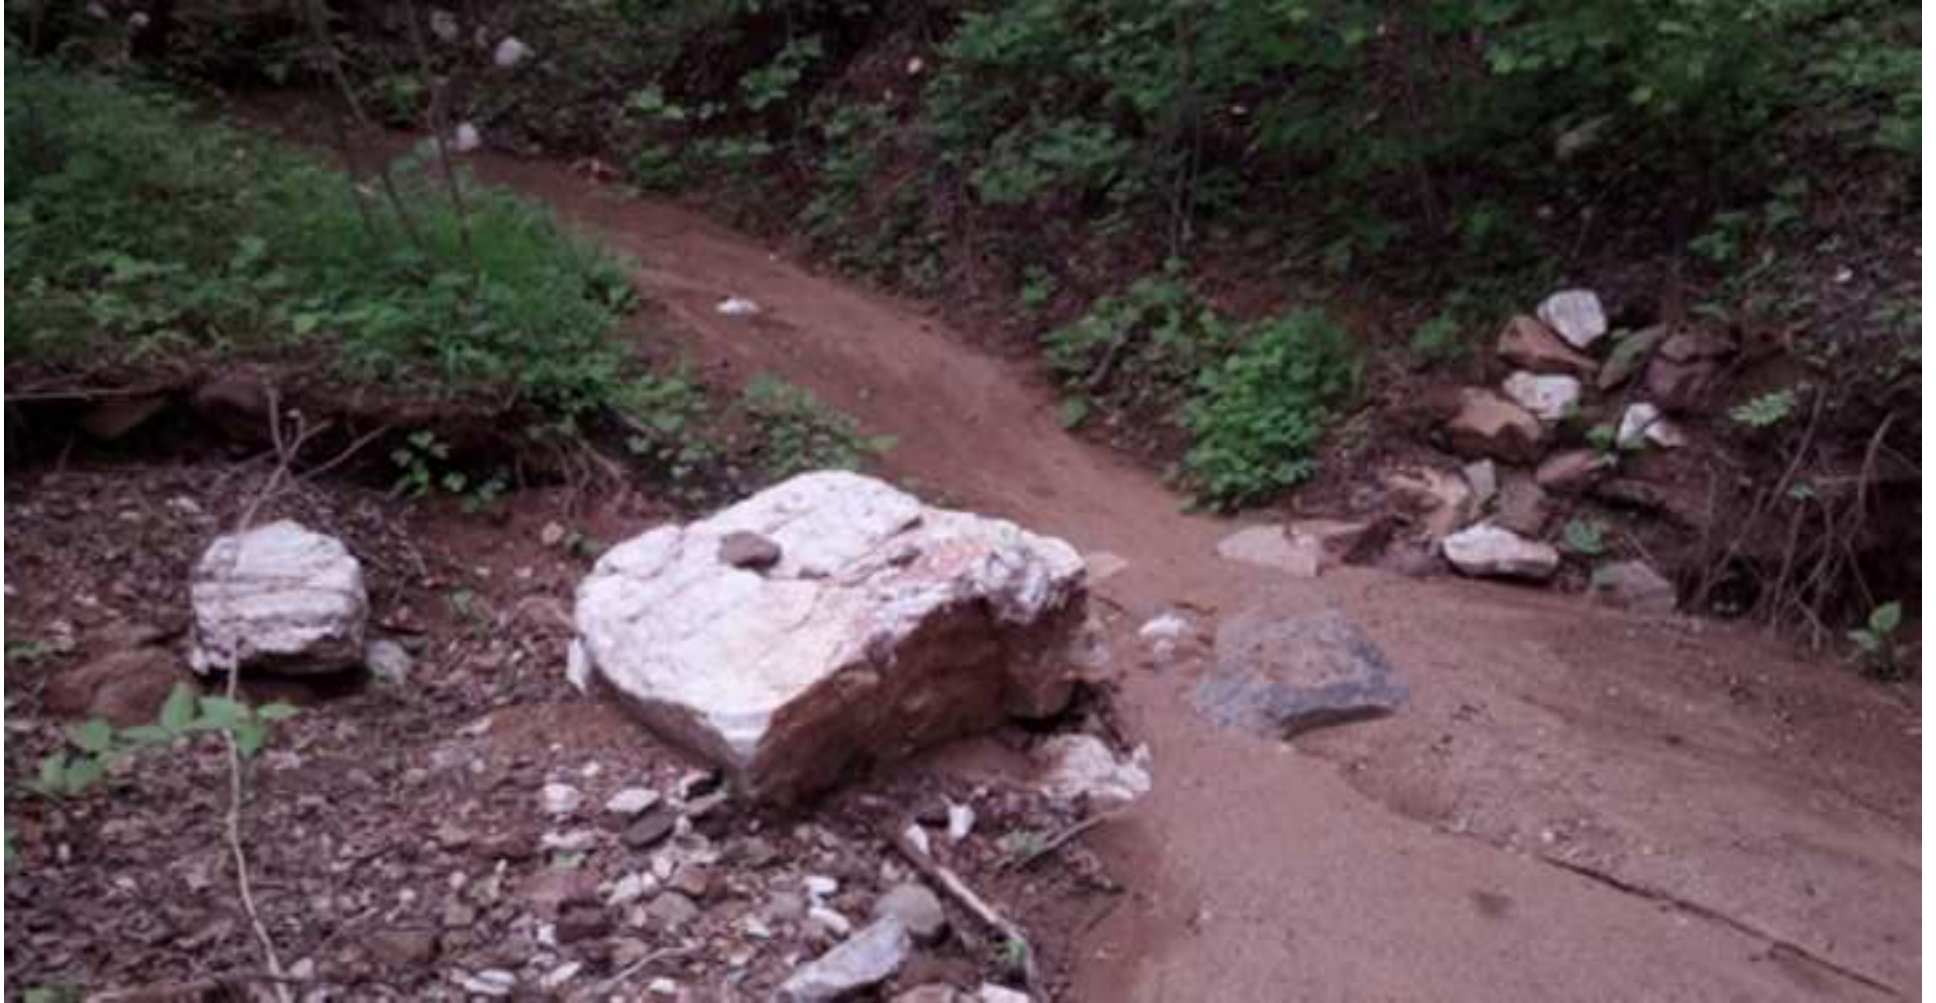
Figure 3
[Click here to download high resolution image](#)

767 Figure 3. Stone check dam failure (broken) in the Culiacan watershed (Mexico).

467 Broken check dams (~~Figure 2~~) retained the capacity to store accumulated sediment
468 (although lower by about 70% than functional check dams). In particular, sediment was
469 stored behind non-broken side walls. The actual sediment storage is similar for
470 functional and filled check-dams, in spite of the higher length of the channel upstream
471 of the latter (~~Table 1~~). On average, the ratio of actual to potential sediment storage of
472 functional check dams (SFD) is close to 50% (~~Table 1~~), which should increase with

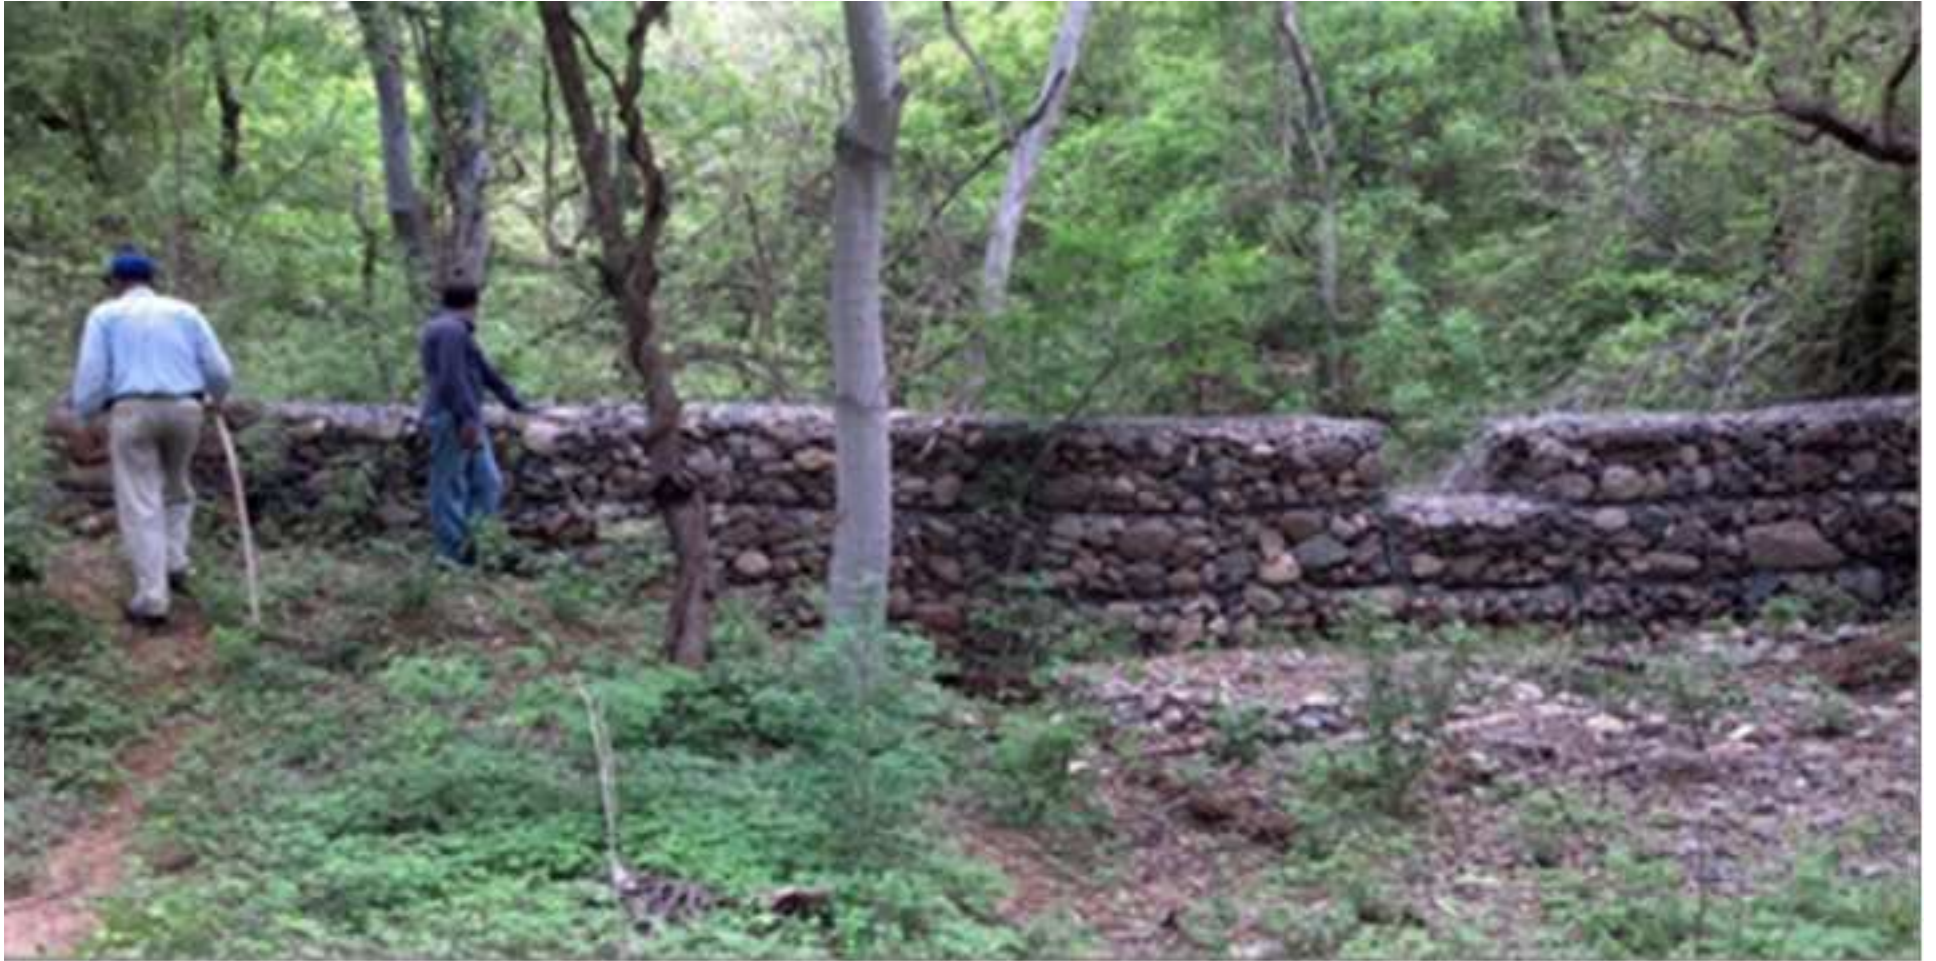
Figure 4
[Click here to download high resolution image](#)

769 Figure 4. A working gabion check dam in the Culiacan watershed (Mexico).

161 In this watershed, small, temporary, stone check dams were constructed across swales
162 and drainage ditches (Figure 3 and 4). These structures were built to reduce flow
163 velocity and thereby potentially control the channel grade and mitigate channel erosion.
164 The maximum height of the stone check dams is 3 metres; to increase their stability, the
165 base of each check dam is embedded into the soil approximately at 1-meter depth. The
166 check dams were constructed to achieve complete cover of the channel and to assure
167 that the middle of the dam is lower than the edges. No large magnitude, low frequency
168 floods were recorded during the period of study (2011-2015). Figure 5 shows a general
169 map and the original/regulated longitudinal profile of four reaches containing the

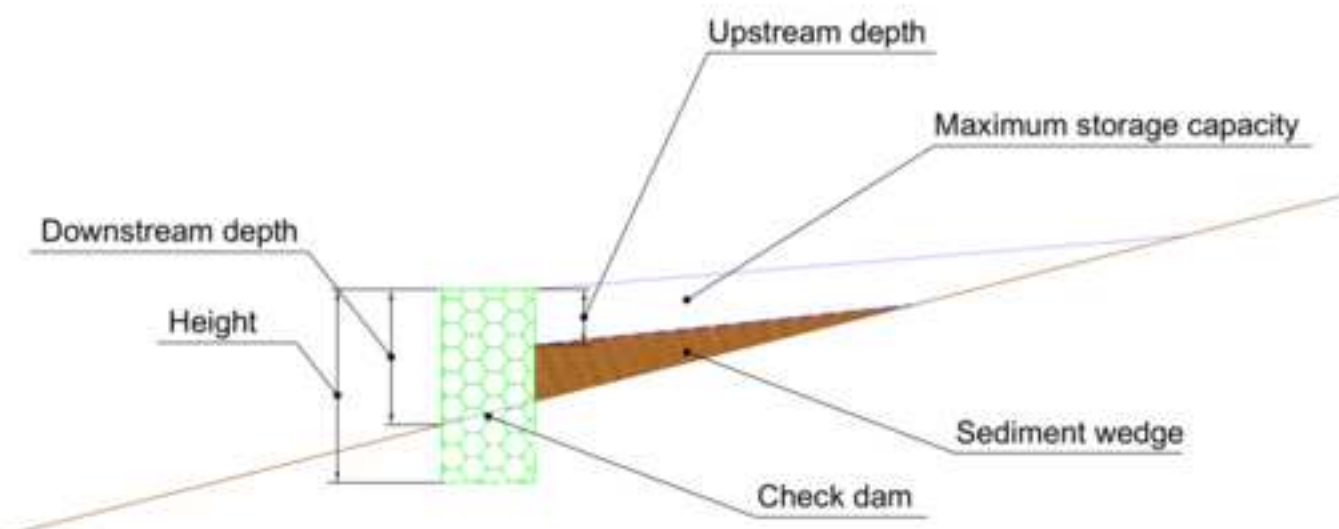
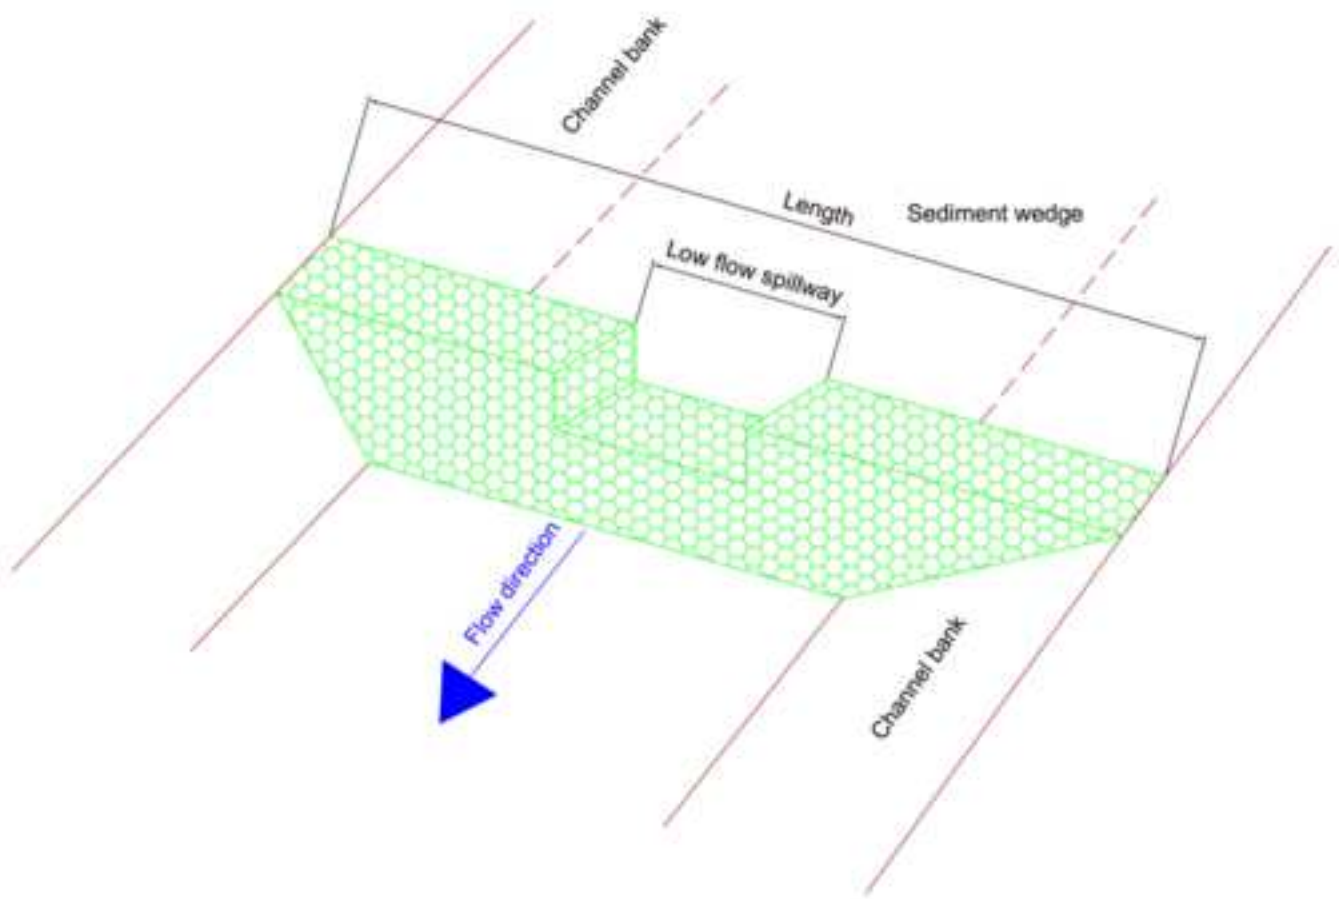
Figure 6

774 Figure 6. Annotated schematic showing side and oblique views of a typical stone check
775 dam in the Culiacan watershed (Mexico).

200 This study was carried out by using a combination of fieldwork and analysis of
201 remotely sensed data. Field surveys were made by Cruz Hernandez et al. (2014) to
202 analyse the operating condition of each check dam. During these surveys, structure
203 dimensions and both upstream and downstream channel morphology were quantified
204 through measurements (Figure 4 6) using standard topographic surveying equipment
