1 **Exploring the influence of vegetation cover, sediment storage capacity and channel**  
2 **dimensions on stone check dam conditions and effectiveness in a large regulated**  
3 **river in México**

50 **Keywords:** Vegetation cover; watershed management; check dam failure; sediment  
51 wedge; soil erosion.

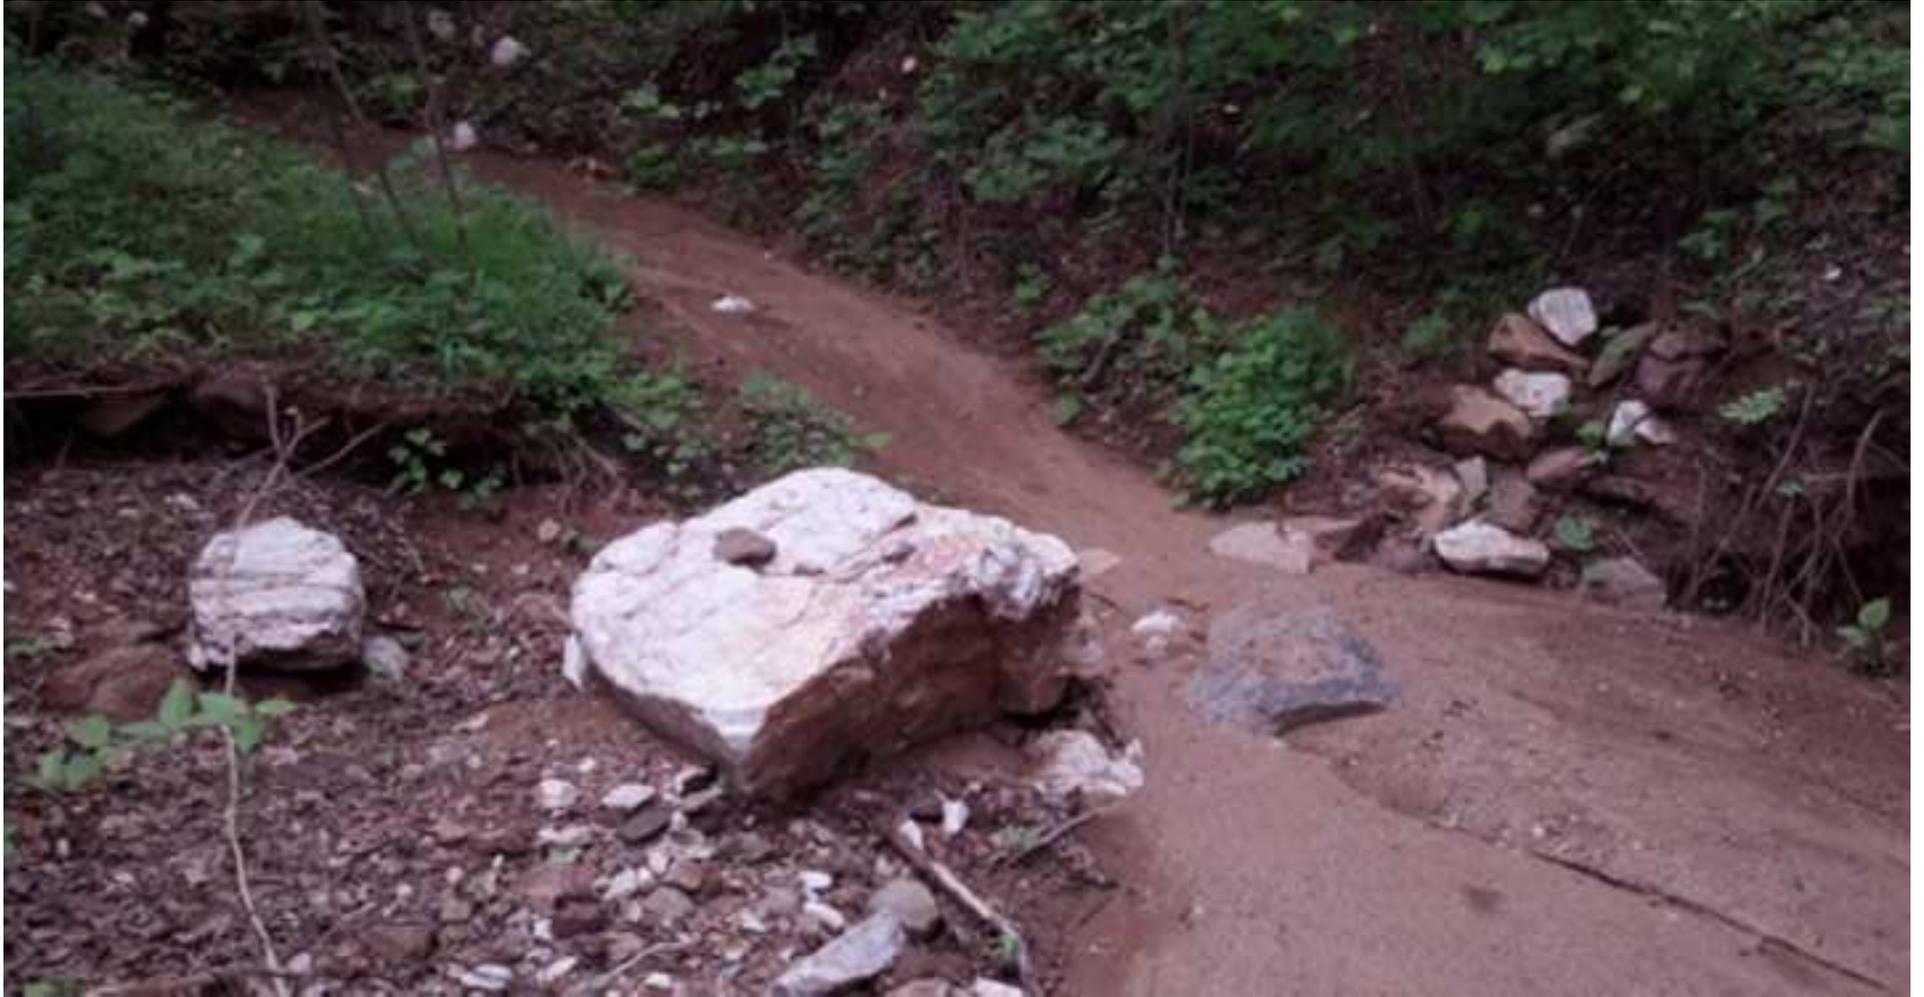
**Figure 3**  
[Click here to download high resolution image](#)

767 Figure 3. Stone check dam failure (broken) in the Culiacan watershed (Mexico).

161 In this watershed, small, temporary, stone check dams were constructed across swales  
162 and drainage ditches (Figure 3 and 4). These structures were built to reduce flow  
163 velocity and thereby potentially control the channel grade and mitigate channel erosion.  
164 The maximum height of the stone check dams is 3 metres; to increase their stability, the  
165 base of each check dam is embedded into the soil approximately at 1-meter depth. The  
166 check dams were constructed to achieve complete cover of the channel and to assure  
167 that the middle of the dam is lower than the edges. No large magnitude, low frequency  
168 floods were recorded during the period of study (2011-2015). Figure 5 shows a general  
169 map and the original/regulated longitudinal profile of of four reaches containing the

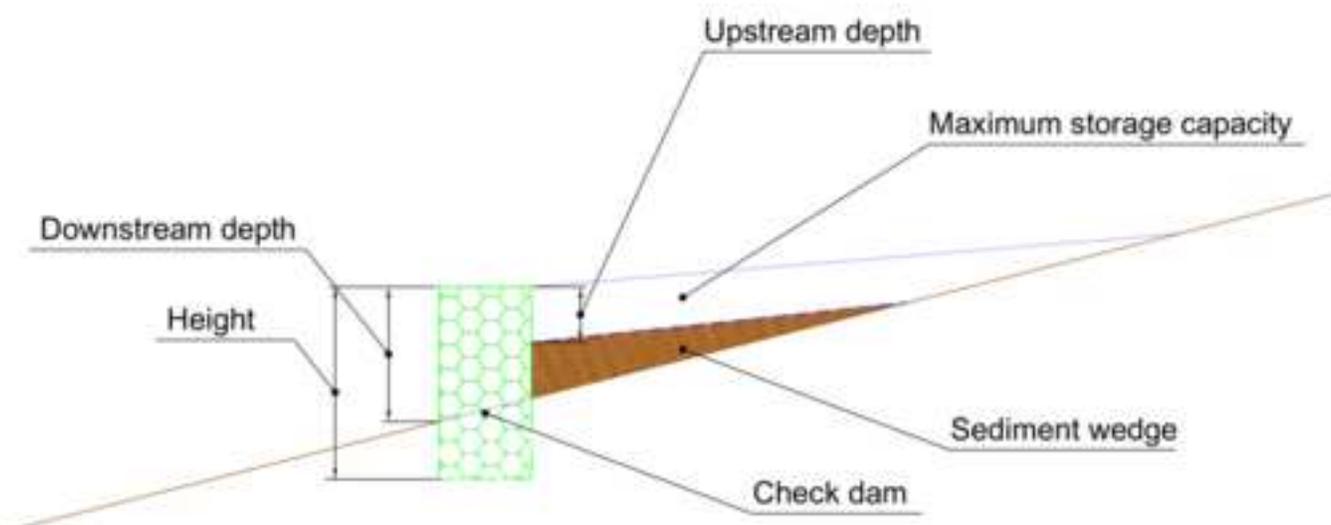
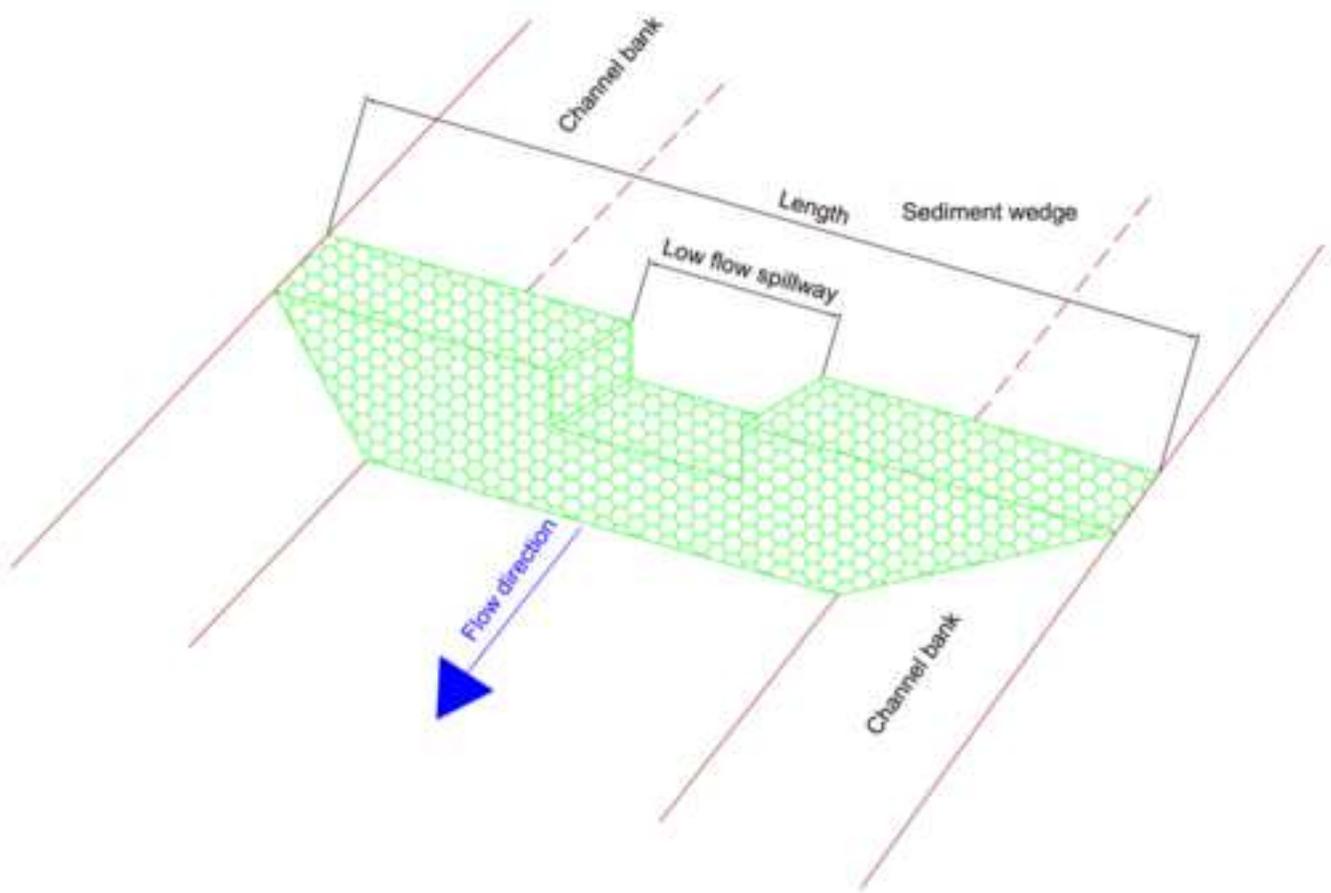
Figure 6

774 Figure 6. Annotated schematic showing side and oblique views of a typical stone check  
775 dam in the Culiacan watershed (Mexico).

204 created before the check dam construction (resolution of 1x1 metres, years 2010-11) or,  
205 when available, from the check dam designs. The two reconstructed longitudinal  
206 profiles allowed reconstructing the sediment wedge dimensions and estimating the local  
207 slope behind each check dam (Figures 5 and 6).
