**Zema D.A., Bombino G., Denisi P., Lucas-Borja M.E., Zimbone S.M. 2018. Evaluating the effects of check dams on channel geometry, bed sediment size and riparian vegetation in Mediterranean mountain torrents. *Science of The Total Environment (Elsevier)*, 642: 327-340,**

1 **Evaluating the effects of check dams on channel geometry, bed sediment size**  
2 **and riparian vegetation in Mediterranean mountain torrents**

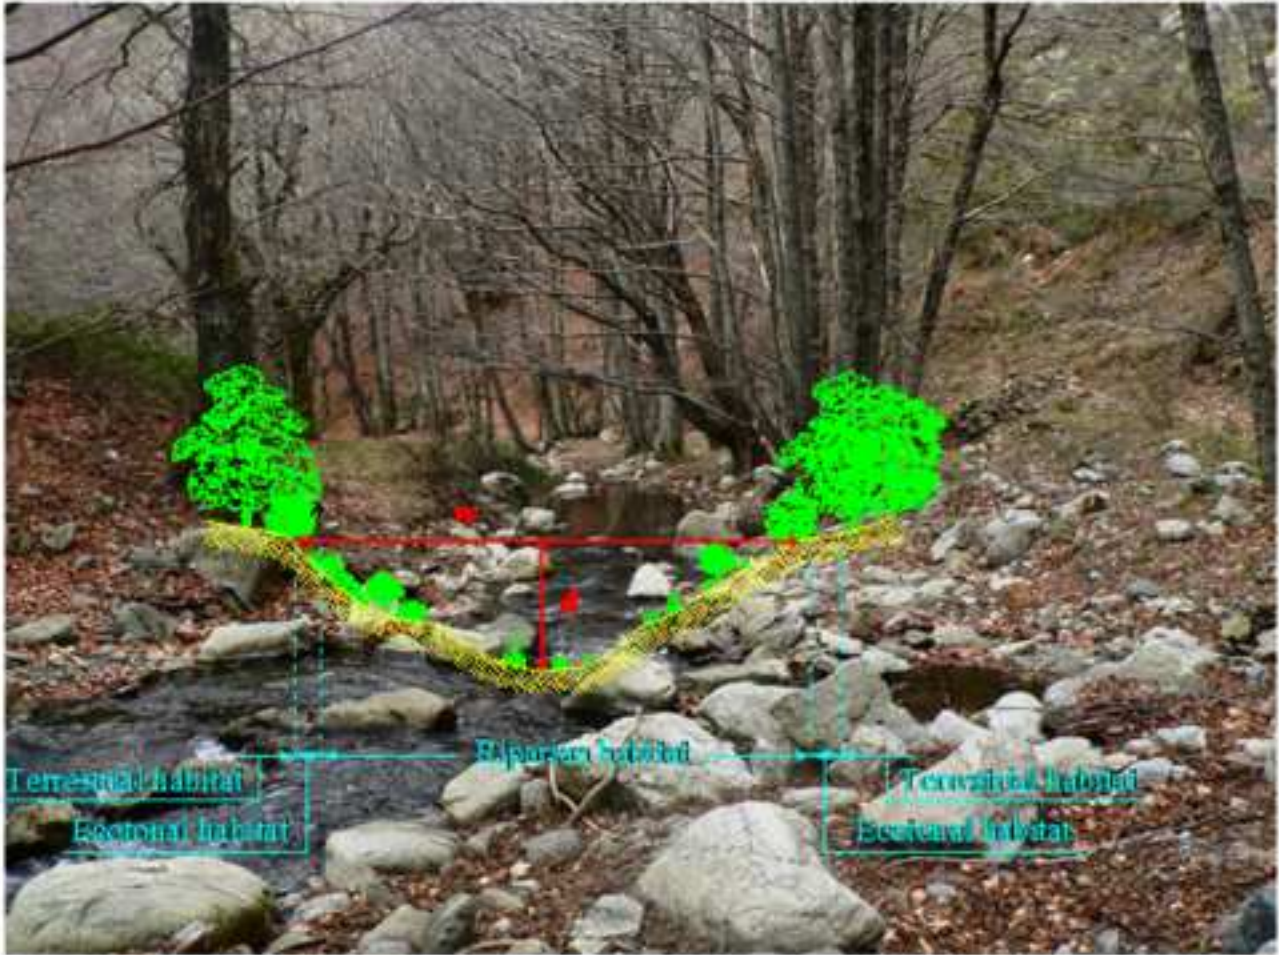
Figure 2  
[Click here to download high resolution image](#)

164 According to the CLC classification of 2016, the land use of the four mountain reaches is  
165 predominantly forest (mainly *Fagus sylvatica* L., *Pinus nigra ssp. laricio var. calabrica* and *Abies*  
166 *alba* Mill.) and shrub, which covers from 77% (SA) to 93% (G) of the headwater area. Other land  
167 uses in the headwaters are intensive crops (on average 20% in the four basins area) and complex  
168 crop system (on average about 5%) (Table 1 and Figure 2).

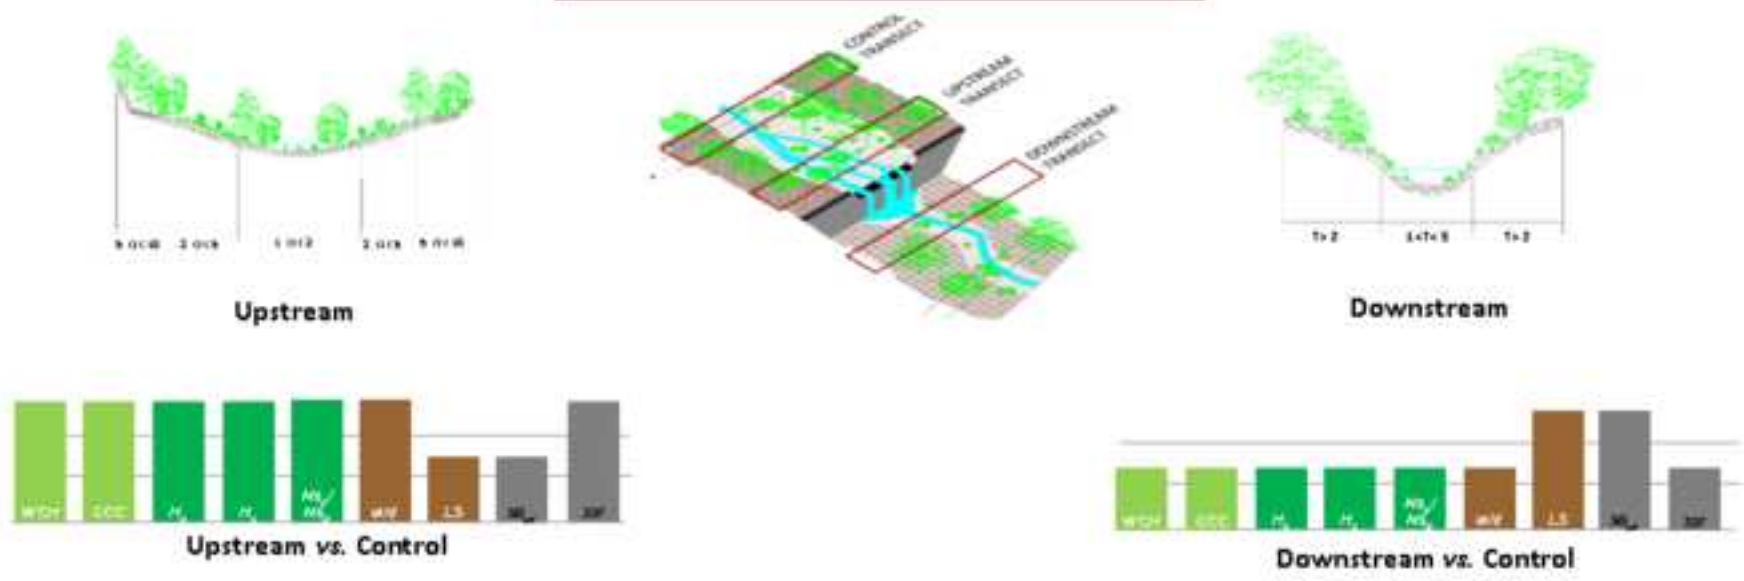
Figure 5  
[Click here to download high resolution image](#)

786 Figure 5 - Scheme of the channel and vegetation dynamics of Mediterranean semi-arid headwaters  
787 under natural conditions (a) and after check dam installation (b).

795 a) *The mountain streams of the Mediterranean semi-arid environment are high-energy and hazardous hydro-systems,*  
796 *characterized by small basins with torrential regime and steep slopes. Frequent and intense rainstorms produce high-*  
797 *magnitude flash floods with high erosive power, often causing hydro-geological instability and destruction of human*  
798 *works. Under natural conditions the active channel shape and profile, the bed sediment caliber and distribution as well*  
799 *as the spatial connectivity of structure, habitat, evolution and biodiversity of vegetation are dominated by a state of*  
800 *non-equilibrium associated with fluvial processes and landform dynamics. These features can be measured in transects*  
801 *of the active channel by a set of significant indicators: channel shape (w/d) and longitudinal slope (LS); water flow unit*  
802 *discharge (q); surface sediment size ( $SD_{50}$ ) and finer sub-surface sediment content (SSF); vegetation extent (GCC) and*

807 b) *In mountain reaches, where natural disturbance plays an important role to maintain discontinuity and diversity of*  
808 *riparian zones, the interaction between hydrological, geomorphological, and ecological processes can be strongly*  
809 *affected by check dams, widely built by local administrations to control and mitigate the hydrological risk over the last*  
810 *70-80 years. The check dams significantly alter ecohydrological and geomorphological dynamics and these changes*  
811 *are evident in transects located immediately upstream and downstream of the check dams compared to the intermediate*  
812 *zone between two check dams (that can be considered as 'control', because they are representative of zones not locally*  
813 *disturbed by check dam and thus reflecting the conditions of the active channel before construction).*
