Experimental Assessment of Climate-Induced Impacts on Heritage Materials: Application of the Damage Index Methodology in the Case Study of Bova

Francesca Giglio and Francesco Armocida(✉)

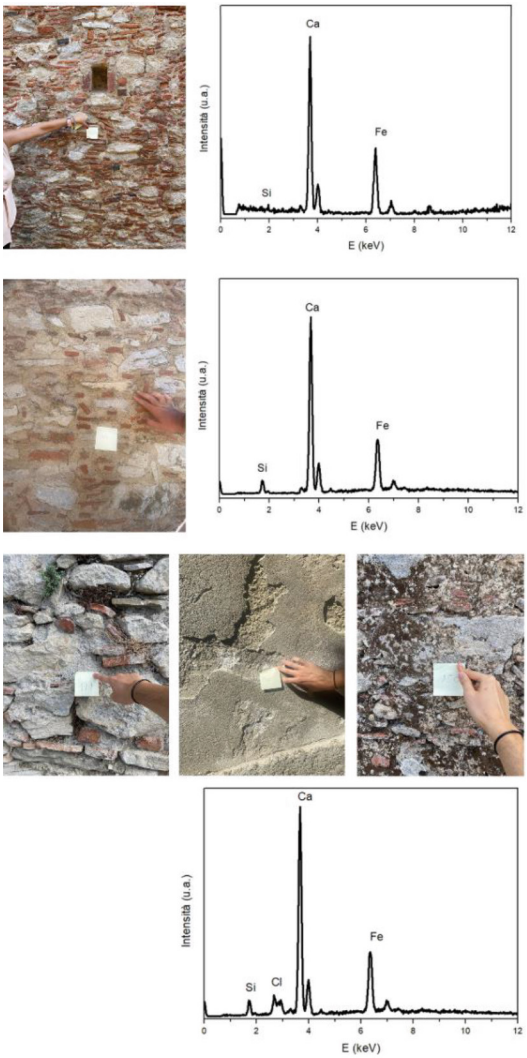
Fig. 10. Representative samples of the structure and corresponding averaged XRF spectra.

- Surface composition: Point-specific XRF analysis identified the chemical composition of surface morphologies, detecting 8 main compounds with a weight percentage >5%. A relative score from 0 to 3 was assigned based on the number of compounds. A low number indicates limited impact, whereas high material heterogeneity can trigger multiple and interconnected degradation processes.
- Degree of surface porosity: Evaluated using ImageJ software by analyzing selected image areas to distinguish voids through contrast and depth calculations. The average porosity measured was 10.7%, significantly influenced by the construction technique involving alternating bricks and stone elements.

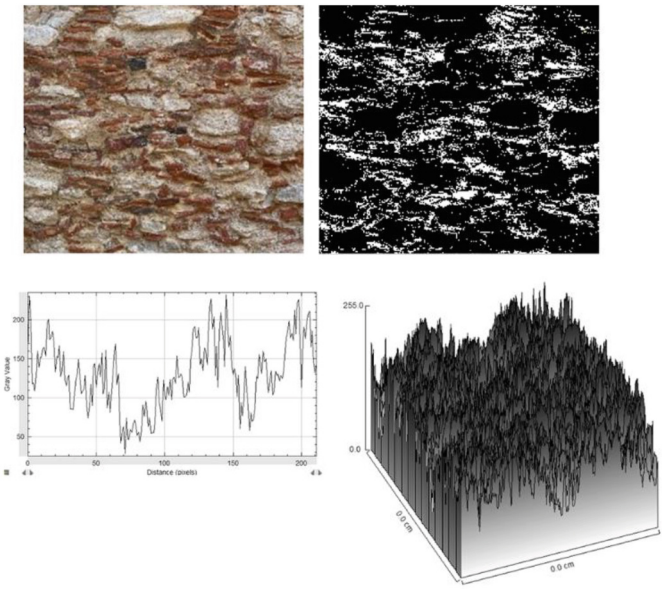
Fig. 11. Analyses obtained using ImageJ software

- ImageJ Software Analysis on Representative Areas: The ImageJ software is used for quantitative evaluations of visual and structural characteristics of surfaces. Specifically, in the described analyses, the software measures parameters such as porosity and surface erosion (Fig. 11).

- Surface erosion: Also analyzed with ImageJ, erosion was quantified as the average depth value across a fixed-width section (50 cm). The surface is generally irregular, and some cavities are due to construction technique rather than erosion. The average erosion percentage was approximately 8.7% (≈4.3 cm per 50 cm at 100%).
- XRD evaluation of crystallinity: Although direct crystallinity evaluation was not possible, the presence of efflorescence and organic deposits (from XRF data) suggests an estimated 10% decrease in surface crystallinity, corresponding to the observed efflorescence extent.

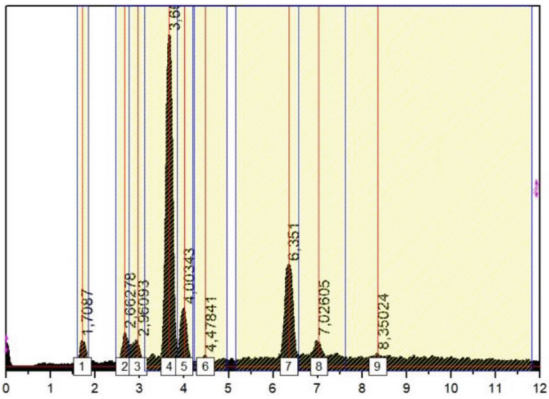
Fig. 12. XRF evaluation elaboration results

- Extension of efflorescence on surface: Visual inspections of selected areas identified efflorescence and organic deposits. The surface coverage was estimated at 1.1% of the total analyzed area (in m^2).
  - XRF evaluation: Targeted XRF spectroscopy detected chlorides typically associated with efflorescence. The ratio between fluorescence peak areas related to efflorescence compounds and those from building materials averaged 0.07 (Fig. 12).
  - Salts deposition: XRF analysis confirmed the presence of chloride-based salts indicative of saline efflorescence. These are attributed to moisture-driven salt migration from the subsoil to the wall surface. Although weight % quantification is complex, it is unnecessary for the index calculation given the limited extension observed.
