Experimental Assessment of Climate-Induced Impacts on Heritage Materials: Application of the Damage Index Methodology in the Case Study of Bova

Abstract. This paper presents an advanced methodology for defining a Damage Index to assess the climate vulnerability of material cultural heritage. The Index is based on three core factors: environmental conditions (F_{env}), material properties (F_{mat}), and external drivers (F_{ext}), each represented by specific indicators, weighted and normalized on a 0–3 scale using the Analytic Hierarchy Process (AHP), allowing for structured risk evaluation. This contribution focuses specifically on the experimental assessment of material factors (F_{mat}), aimed at determining the physical and chemical properties of heritage materials through a replicable site-specific approach. The study is structured in three sections: the first outlines the overall framework of the Index; the second details the experimental and simulation procedures for assessing material properties; the third presents its application to the case study of Palazzo Mesiani in Bova (Reggio Calabria). These analyses were conducted by the MATeRICs Interdepartmental Laboratory at Me

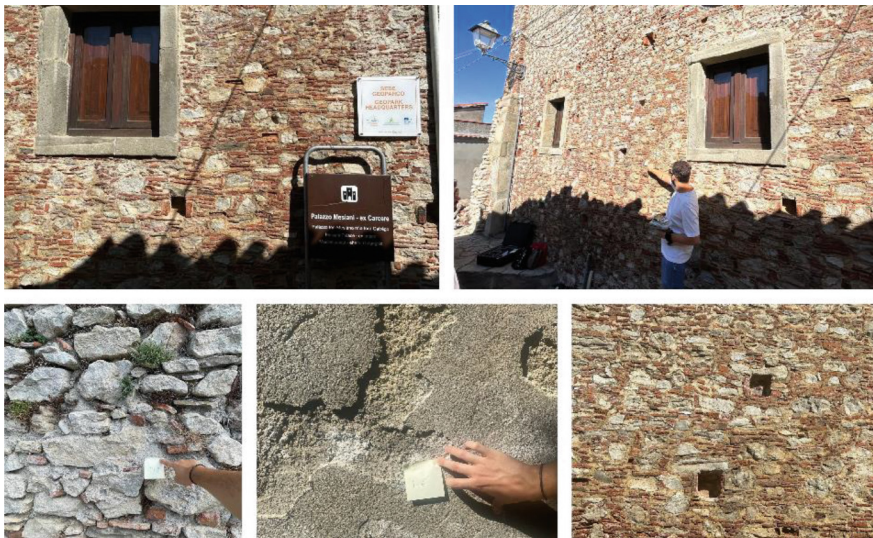
Macroscopically, it is possible to observe the presence of heterogeneous materials in this building, due to the combined use of different types of original materials, as well as more recent materials likely introduced during reconstruction and/or maintenance work.

Indeed, from an initial visual inspection, the main materials constituting the structure are evident: local stone, identified as limestone or sandstone, already studied in other buildings in nearby areas and typical of many historic buildings in Calabria; bricks made of local clay, which are significantly present in this structure; mortar used to bind bricks and stones; and cement, found in some areas, likely due to restoration or adaptation work. The experimental analyses and simulation methodologies were first carried out in-situ (Fig. 8) and then processed in the laboratory.³

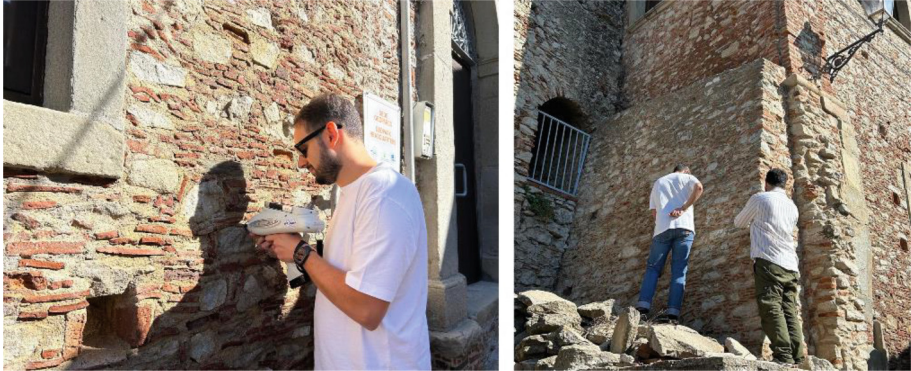
Fig. 9. Application of spectroscopy and analysis sampling, Palazzo Mesiani, Bova (RC)

Experimental analyses were conducted on various points of the masonry by means of X-ray Fluorescence Spectroscopy (XRF) to determine the chemical composition of materials. The microstructural and chemical characteristics were directly identified on-site using XRF analysis (X-ray fluorescence). Given the building's large dimensions, the most representative points of the entire structure were analyzed, and the results obtained were appropriately averaged (Fig. 9).
