LOST AND FOUND. Processes of abandonment of the architectural and urban heritage in inner areas: Causes, effects, and narratives (Italy, Albania, Romania)

ArchistoR EXTRA 13 (2024), Supplement of ArchistoR 19/2023

Notes on the Effects of Natural Disasters on Small Towns and Villages in Calabria during the 20th Century. The Case of Ferruzzano

Nino Sulfaro

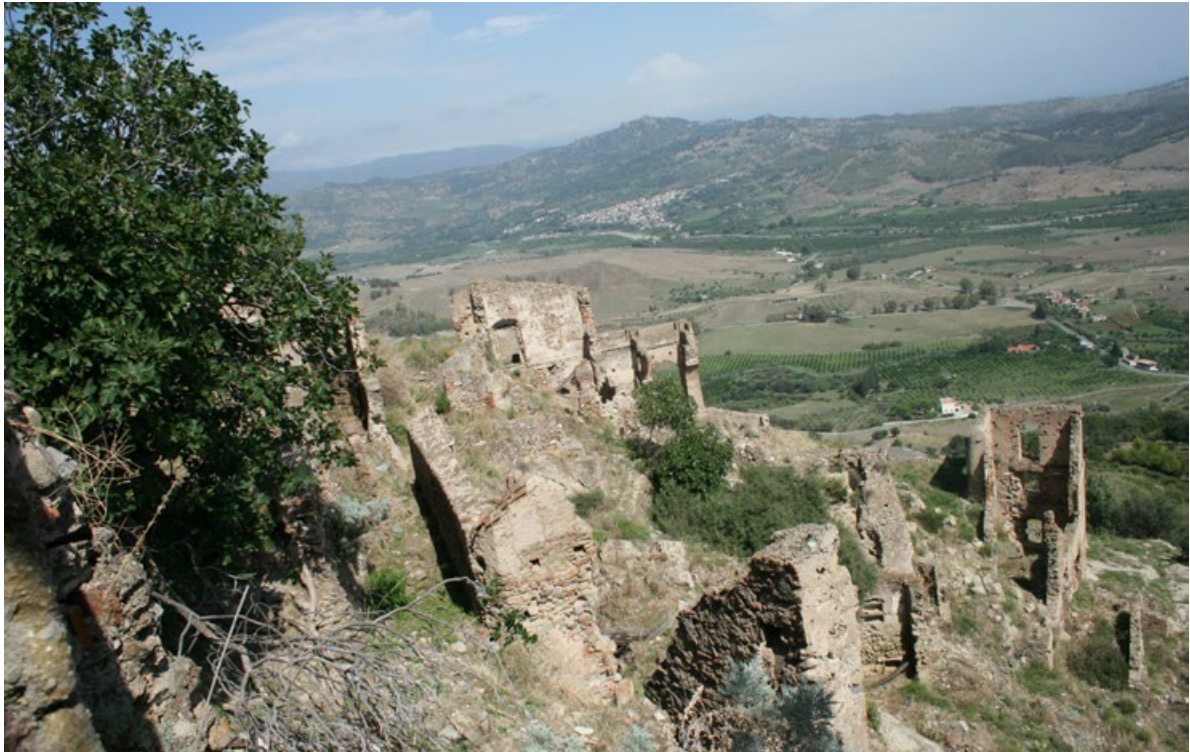
Figure 1. Brancaleone Superiore, Reggio Calabria. Ruins of the old settlements abandoned during the 20th century due to hydrogeological disorder and never demolished (photo N. Sulfaro, 2015).

Although the natural disasters which occurred in Calabria – earthquakes, landslides and floods – during the 20th century have been numerous and have often caused very serious damage, identifying the effects on the built heritage is quite difficult. One of the reasons for this lack of identification is that much post-disaster intervention work was not fully documented. Thus, there is very little literature on the subject and the archive documents have practically never been ordered and classified¹. The 1908 earthquake is an exception where there is a significant number of studies and archive documentation available, relating, however, almost exclusively only to the two large centers affected by the disaster, Messina and Reggio Calabria². The two cities, in fact, were the only ones to be rebuilt through a specific project and to have part of their monumental heritage reconstructed, restored, and repaired. The small towns and villages of the provinces, particularly in inner areas, however, were almost never the object of reconstruction plans: in most cases, relocation was preferred, abandoning the old settlements which, for safety reasons, should have been even demolished³. This rarely happened, and the old settlements were abandoned and destined to become ruins (fig. 1).

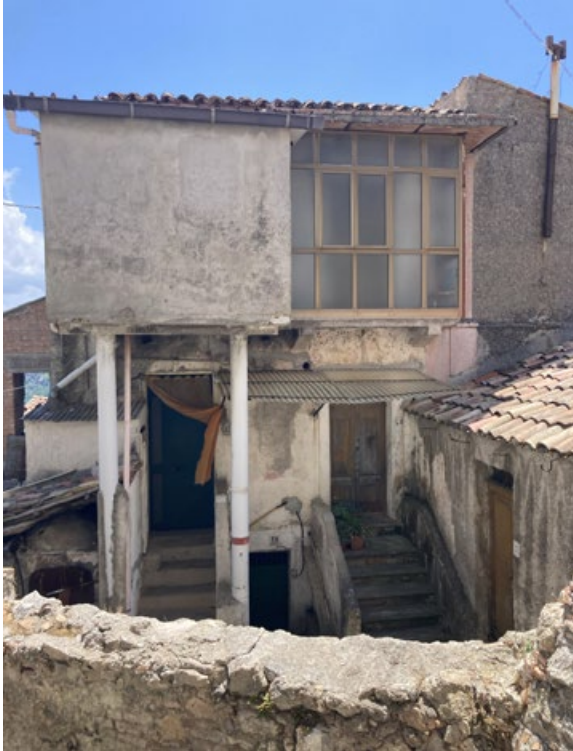
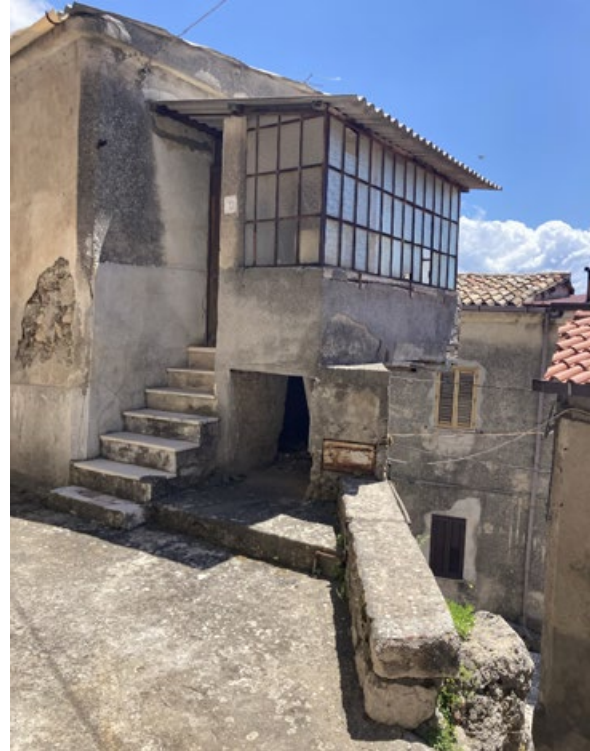
Figures 2-3. Canolo Vecchia, Reggio Calabria. Some patchy transformations show how the old small town has been partially inhabited over time (photos N. Sulfaro, 2022).

Some other small towns, however, continued to be partially inhabited for the entire century, and were the subject, over time, of patchy interventions of reconstruction, repair and demolition by the owners of those structures which, from time to time, due to further earthquakes or floods, were no longer safe (figs. 2-3).

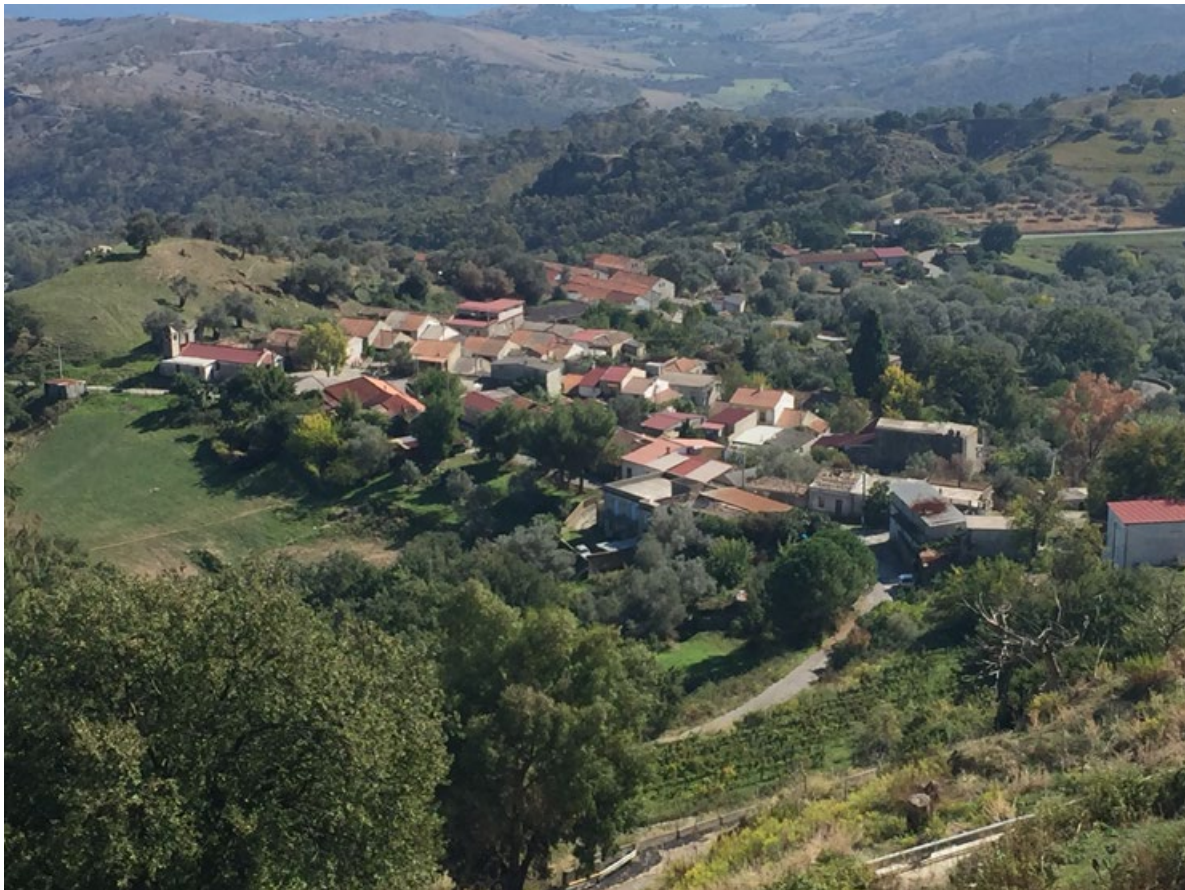
Figure 9. Ferruzzano, Reggio Calabria. The new town of Saccuti (photo N. Sulfaro, 2018).

A first provisional encampment was set up in Saccuti, an area close to Ferruzzano, where the inhabitants were supposed to be temporarily relocated (fig. 9). Government inspectors proposed that the Committee consider the hypothesis of reconstructing the town in another place due to the great difficulties of rebuilding the town on the original site. By the end of 1907, nothing had yet been rebuilt. Funds were allocated for housing to shelter homeless families, in Saccuti, closer to Ferruzzano where, in the aftermath of the disaster, a provisional encampment had been established. Here, tents were transformed into brick houses.

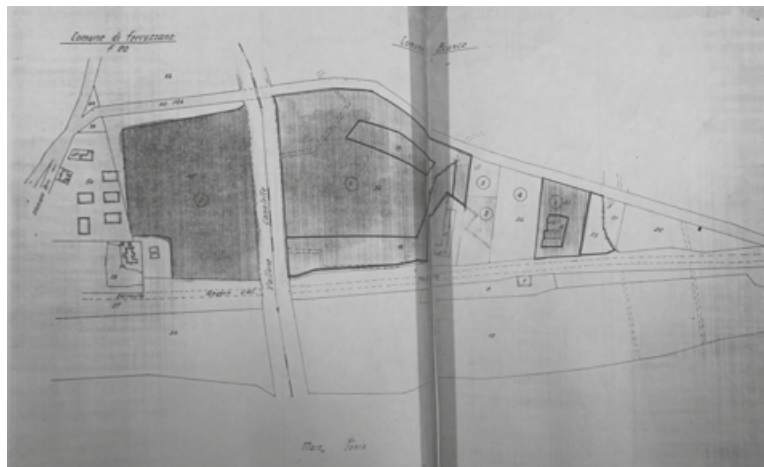
On the left, figure 10. First plan for the relocation of Ferruzzano in an area upstream from the national road (ASRC, Consolidamenti e trasferimenti degli abitati, Trasferimento dell'abitato di Ferruzzano centro e della frazione Saccuti). Below, figure 11. Particular of the general plan of the realcaiont of Ferruzzano and Saccuti by the company Lodigiani in 1985 (*Concorso per la realizzazione del trasferimento dell'abitato di Ferruzzano Centro e Saccuti*) (ASRC, Consolidamenti e trasferimenti degli abitati, Trasferimento dell'abitato di Ferruzzano centro e della frazione Saccuti).

Subsequently, while the new homes were still being built in 1973 and the families were only partially relocated, another settlement upstream from the national road was planned for a further 300 families. The construction of this new settlement was to continue until 1985 and would only be partially built¹⁹ (figs 10-11).

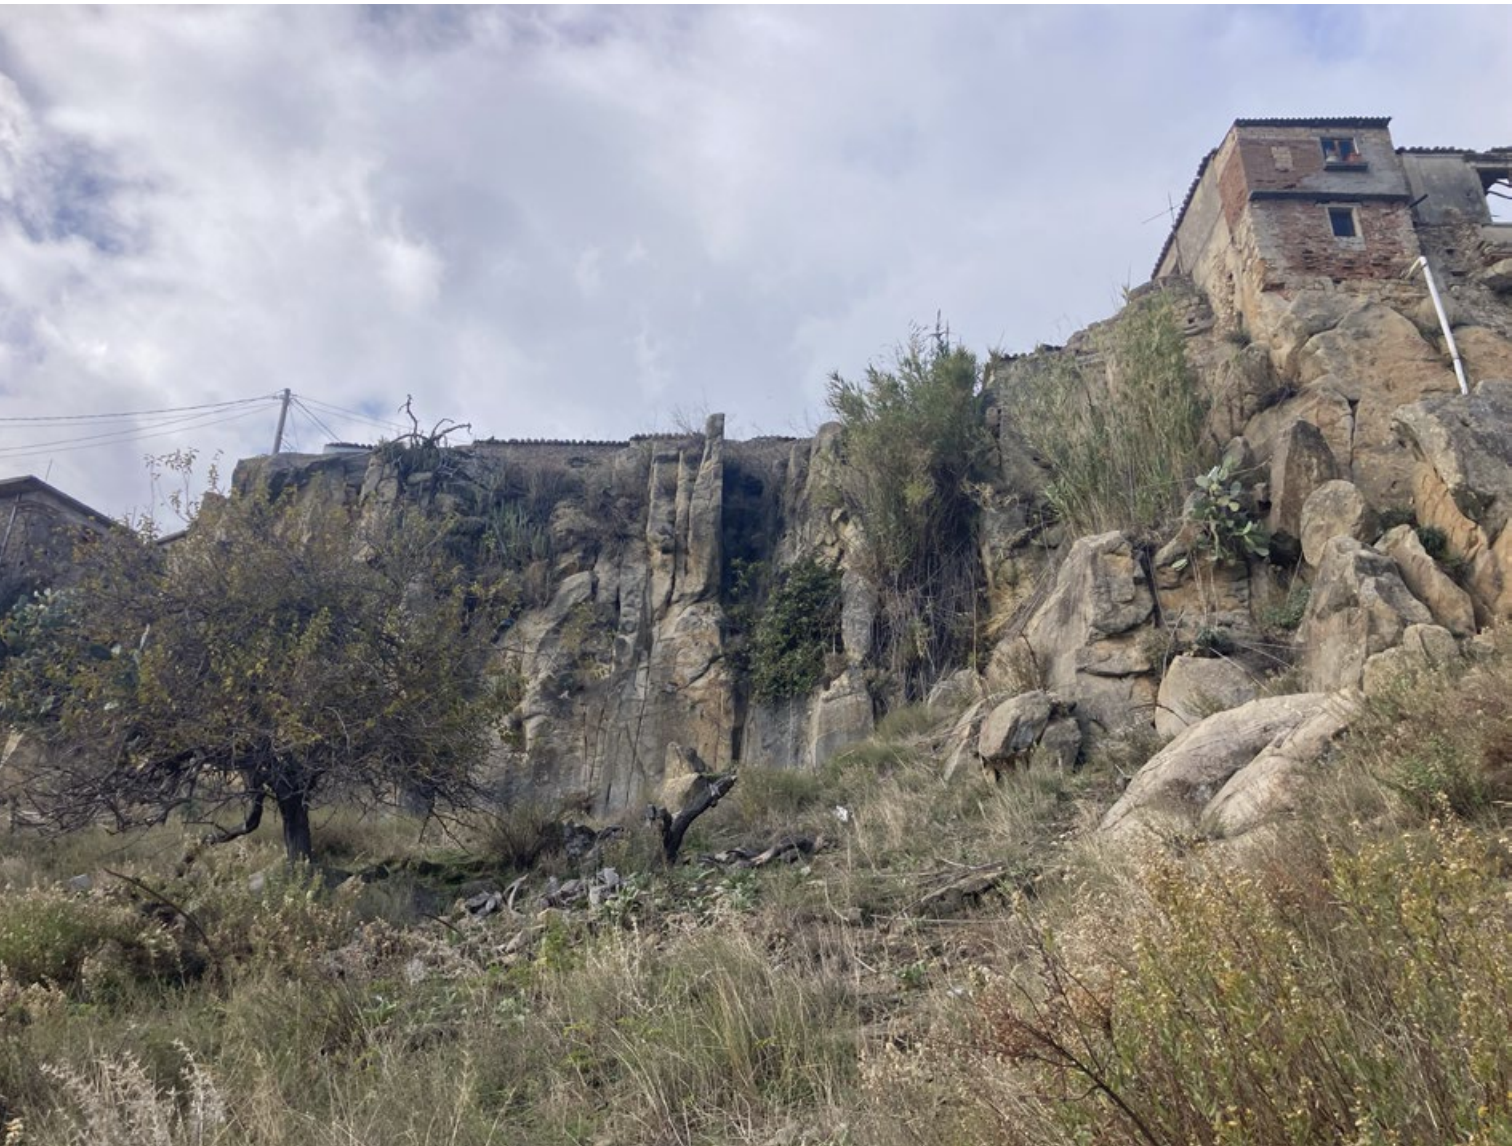
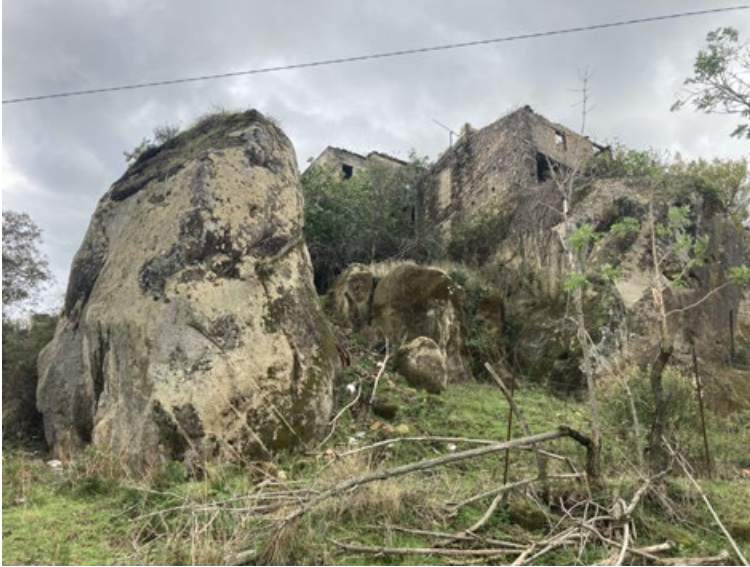
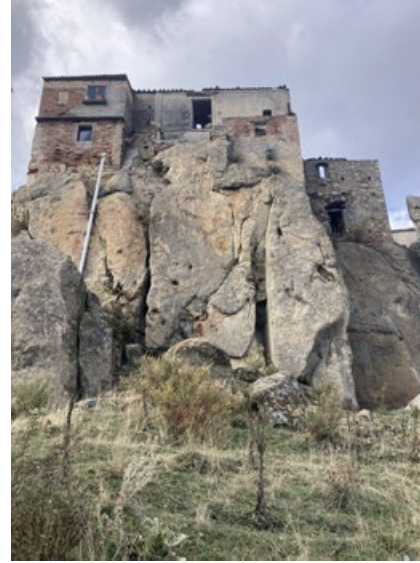
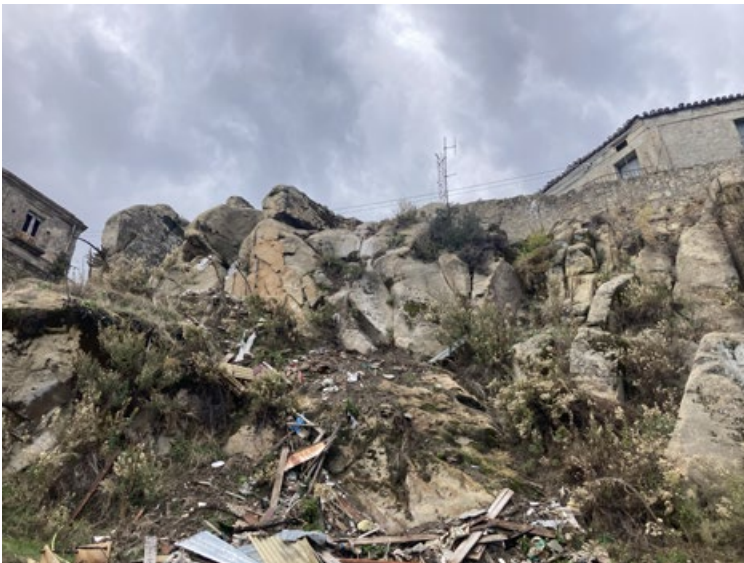
On the previous and on this page, figures 13-16. Ferruzzano, Reggio Calabria. The rocky outcrop where Ferruzzano is located shows a prevalent division according to vertical planes and prisms (photos N. Sulfaro, 2023).

geological characteristics of the land, but also analyzed the conditions of the buildings, paying particular attention to the construction techniques used, as a factor that aggravated the effects of the earthquake. He underlined the role of the soil-building relationship, observing how in this part of Calabria foundations were a rarity in buildings: «the houses ordinarily rest on the ground, even if this is on a steep slope, or on vertical cliffs, therefore while upstream they have one or two floors, downstream they have three or four»²⁷. He observed how often in Calabrian settlements the houses rested on the rock outcrops, like in Africo, or almost suspended over the void like on the crags, as in Roccaforte del Greco and in Roghudi. According to Sabatini, even without the help of an earthquake, in these cases the houses were destined to collapse with the slow crumbling of the underlying crags. In fact, these were often seen fractured underneath the buildings, as in Gerace, Roccaforte, and Ferruzzano²⁸. As in other sites, including Bruzzano, and Brancaleone, where these formations are reduced to a mass of blocks *in situ* (fig. 12), the sandstone that forms the rocky outcrop where Ferruzzano is located shows a prevalent division according to vertical planes and therefore prisms, whose disintegration, according to Sabatini, was the main cause of the 1907 earthquake disaster (figs. 13-16). Among the lesions observed by the geologist, there were older and more recent ones; among the former, as shown in a drawing (fig. 17), there is the lesion that crossed the town, bordering the Croce and Belvedere districts and which locals dated back to the 1783 earthquake. Furthermore, along the crags, several prisms also show transversal fractures; some prisms can be seen completely detached from the remaining rock, and above one of them rests an abandoned house²⁹ (figs. 18-21). In the earthquake of 1907, a part of the town above the crags was destroyed, falling into a chasm following the rotation and subsequent collapse of the underlying prisms. At the same time, the internal fractures of the rock accentuated that movement and many other houses collapsed or were damaged³⁰.

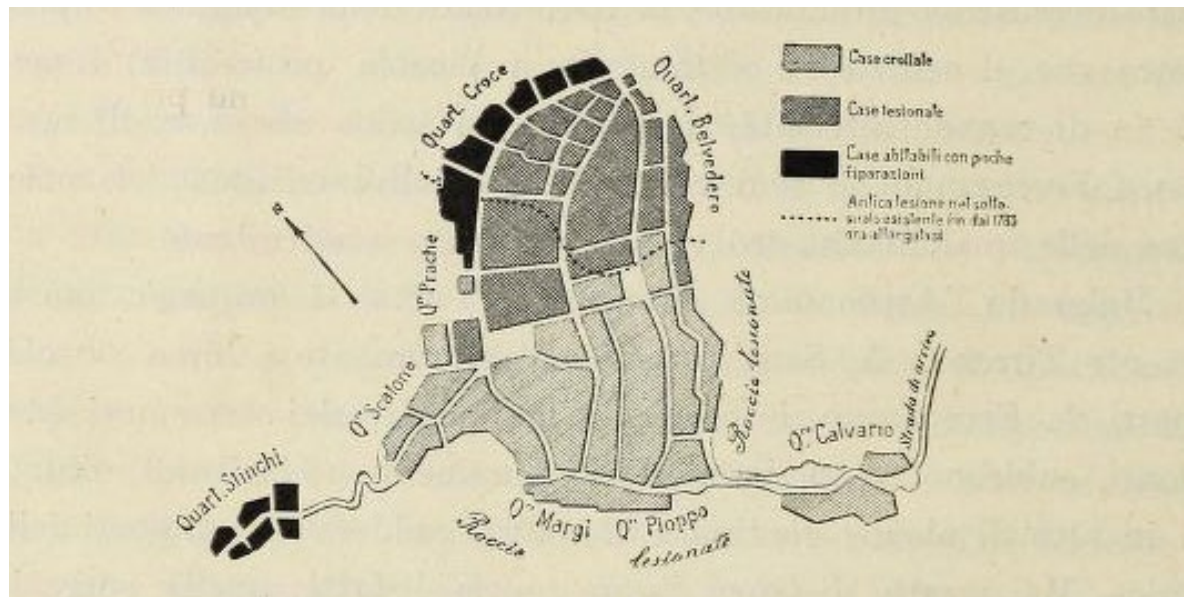
Figure 17. Map of Ferruzzano after the earthquake of 1907 with the indications of damage and collapses. It includes also the sketch of a lesion that crossed the town which locals dated back to the 1783 earthquake (SABATINI 1908, p. 34).

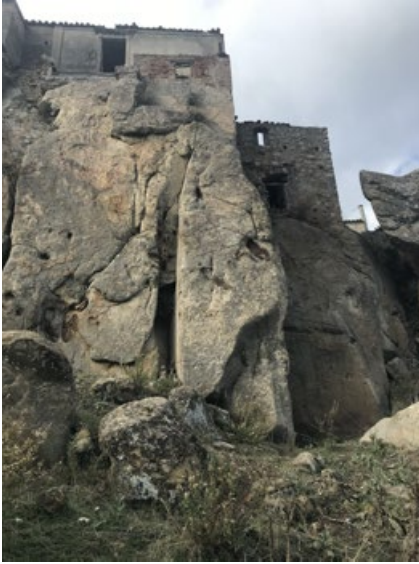
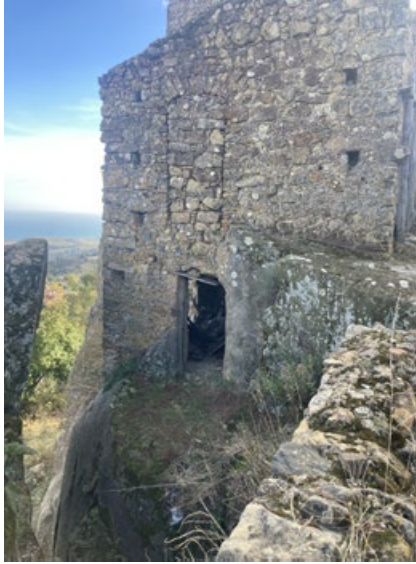
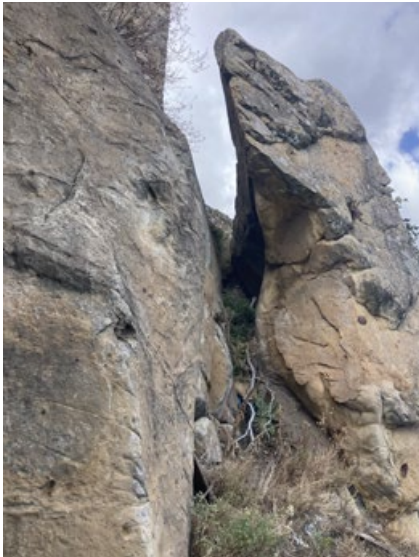
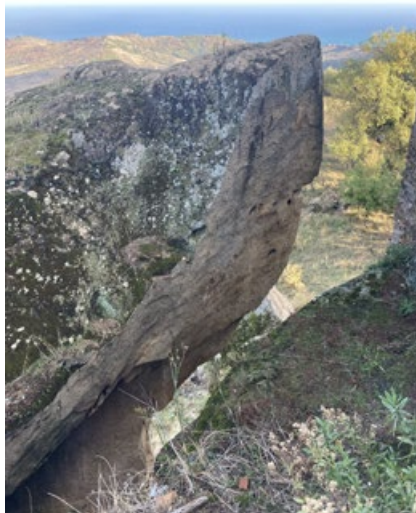
Figures 18-21. Ferruzzano, Reggio Calabria. One of prisms completely detached from the rock (photos N. Sulfaro, 2023).

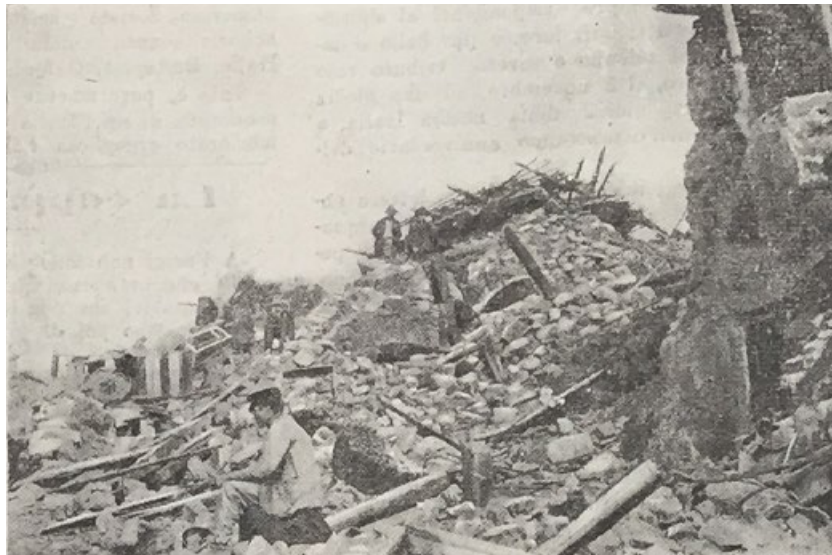
Figure 22. Ferruzzano, Reggio Calabria. View of the ruins after the earthquake of 1907 from a magazine of the time (private collection of the author).

Apart from Sabatini's studies and the general data relating to the damage to buildings in percentage, there are no studies or archival documents relating to the individual damage recorded on buildings. The only post-earthquake pictures we have effectively describe the rubble scenario, but do not allow us to identify still existing buildings (fig. 22). The 1908 earthquake occurred when the rubble had not yet been moved away, and probably no interventions were made on buildings in terms of

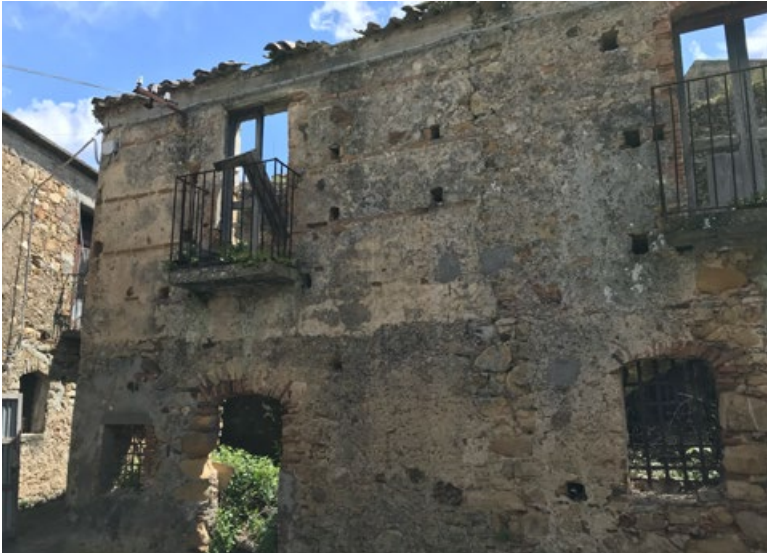
Figure 23. Ferruzzano, Reggio Calabria. The insertion of a portion built after the earthquake of 1908 on a pre-existing undamaged masonry (photo N. Sulfaro, 2022).

The severely damaged walls, uneven ones, and those which had widespread cracking, had to be demolished. Walls damaged more lightly, however, could be repaired by adding on each individual crack of new masonry well attached to the pre-existing, undamaged one³² (fig. 23).

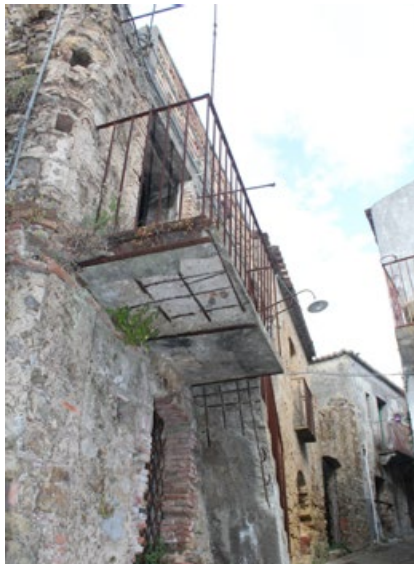
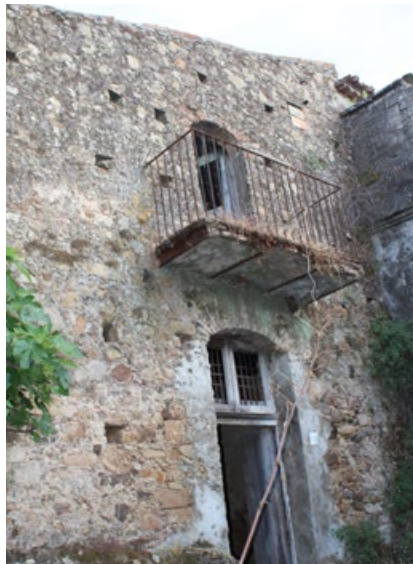
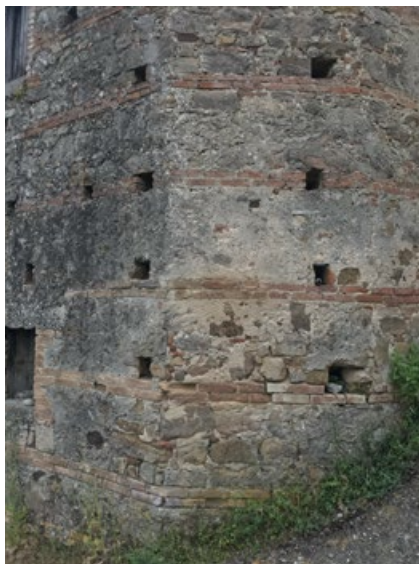
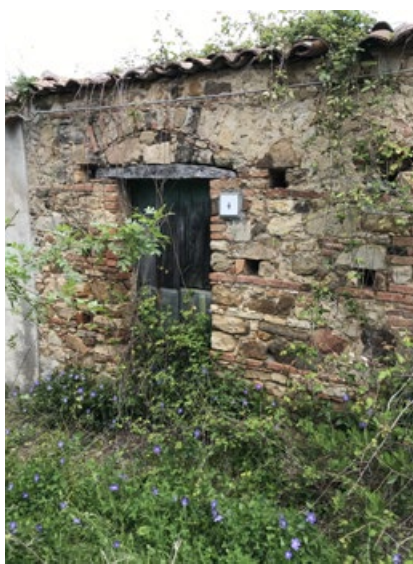
Figures 24-29. Ferruzzano, Reggio Calabria (photos N. Sulfaro, 2023).

Reinforced masonry systems and the adoption of connections between the different structures of the buildings were prescribed; the use of vaults was prohibited, and the use of slabs was imposed, outlawing any overhanging construction, except balconies which had to comply with precise construction standards (figs. 24-25).

One of the most evident post 1908 earthquake reconstructions are the presence of new structures made with stone masonry interrupted by horizontal lines of bricks at a distance not more of 60 cm (figs. 26-27). Generally it is also possible to distinguish interventions attributable to the post-1908 earthquake phase, whose characteristics are directly referable to the prescriptions included in the laws issued in the aftermath of the disaster, such as demolition of damaged upper floors.

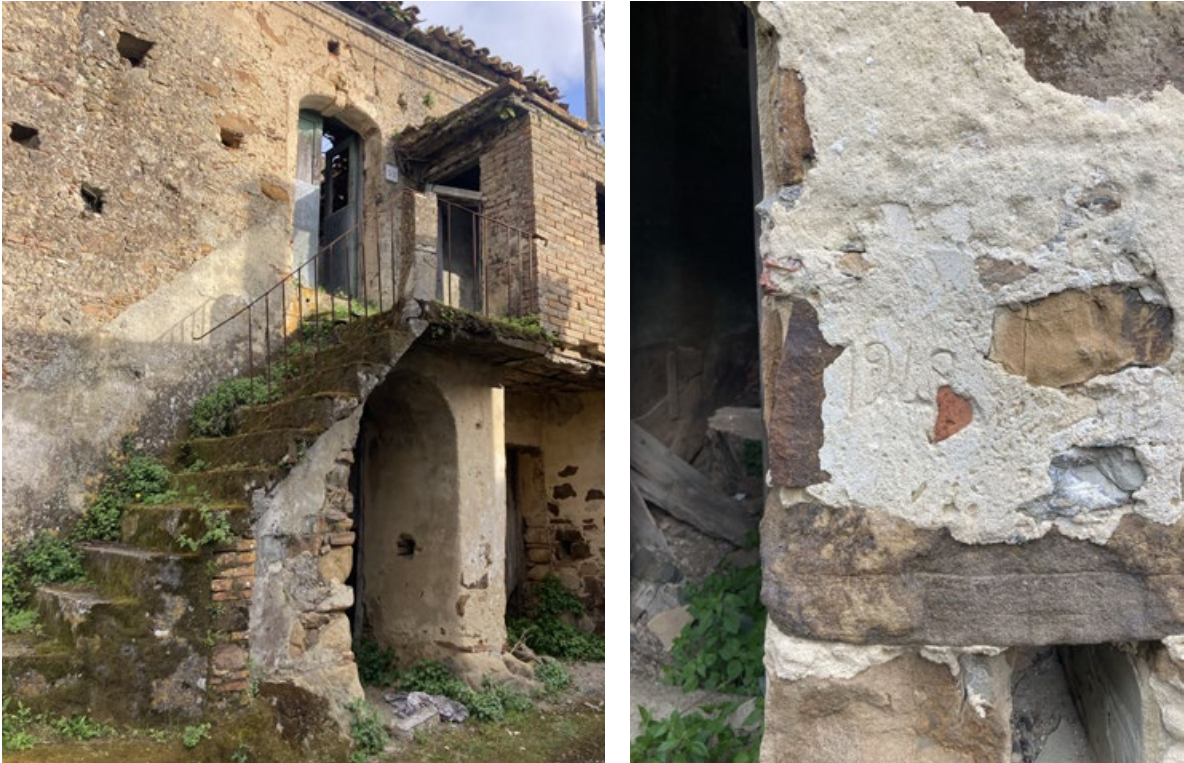
Figures 30-31. Ferruzzano, Reggio Calabria (photos N. Sulfaro, 2023).

With the same approach it is often possible to recognize transformations of a distributional-functional nature, carried out not as a consequence of interventions aimed at increasing the safety of the buildings, but of a new socio-economic structure of the small towns in the various periods (figs. 28-29). In addition, based above all on the observation of the introduction of new materials and constructive techniques (e.g., reinforced concrete, new architectural finishings, etc.), it is possible to recognize interventions attributable to the post-World War II period and even more recent phases (figs. 30-31).
